# **Flood Investigation Report Havenwood Road, Whitley**

**November 2023**

**Flood Investigation Report**

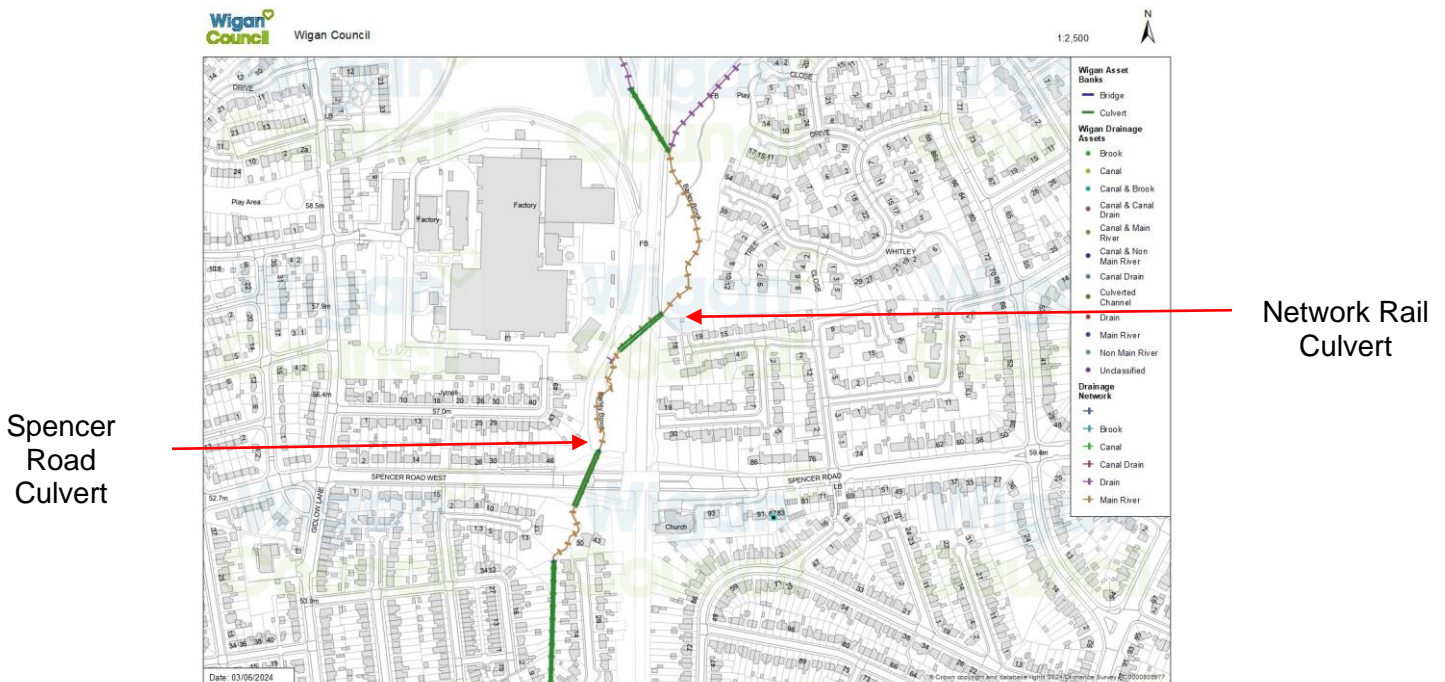
#### *Figure 4 – Barley Brook Culvert Locations*

The report provided by Network Rail indicated that a blockage was likely to be present downstream of the railway culvert as the water levels remained at a consistent height on both sides of the structure. Upon receiving this report an officer from Wigan Council's flood risk team investigated the downstream sections of the watercourse and found that the culvert beneath Spencer Road West had become completely blocked by debris. The debris, which consisted of a combination of fly tipped tyres and tree branches, accumulated at the inlet of the culvert severely restricting downstream flows. Once the blockage had been removed the water level receded and conditions within the watercourse upstream of the culvert returned to normal.

It was also found that the debris screen at the inlet to the Spencer Road culvert had been damaged and was no longer operational. A replacement screen has been ordered to prevent blockages within the culvert. The new screen will be designed to prevent debris from blocking the inlet while allowing downstream flows to continue unimpeded.

Following the works to clear the Spencer Road culvert it was observed that water levels remained high just upstream of the culvert beneath the railway. Network Rail investigated and reported that there was a partial blockage that had restricted flows downstream. This signifies that there were multiple blockages along the watercourse that contributed to the flooding. This blockage was cleared by Network Rail immediately following the investigation to ensure that there are no further restrictions on flow.

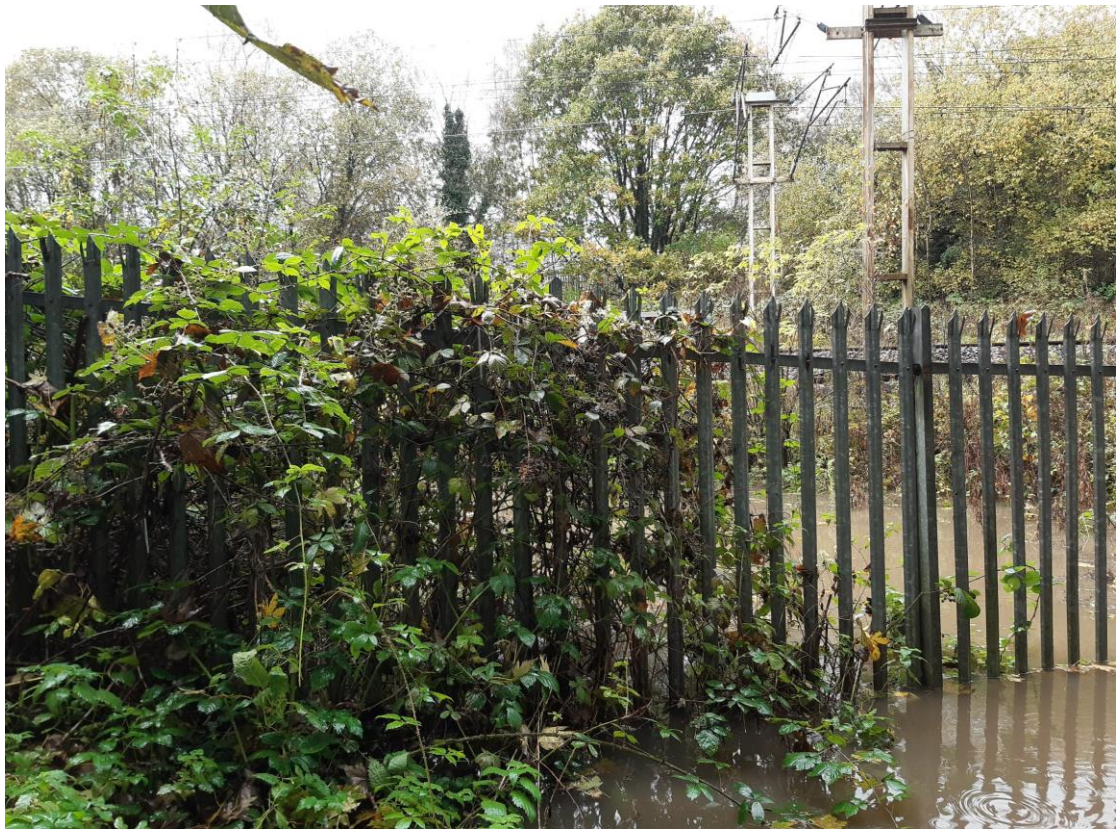
Network Rail officers were on site to investigate the report by the flood risk officer and residents that the culverted section of Barley Brook beneath the railway had become blocked by debris. The flooding on Havenwood Road and May Tree Drive began to dissipate at approximately 03:00 on the 7<sup>th</sup> of November.

*Figure 1 - Flooding at Inlet to Network Rail Culvert. Inlet is submerged. Facing Downstream*

Network Rail	<ul style="list-style-type: none"> <li>• Undertake an underwater survey of the culvert.</li> <li>• Regularly undertake Inspections of Network Rail assets while adhering to a routine maintenance schedule.</li> </ul>

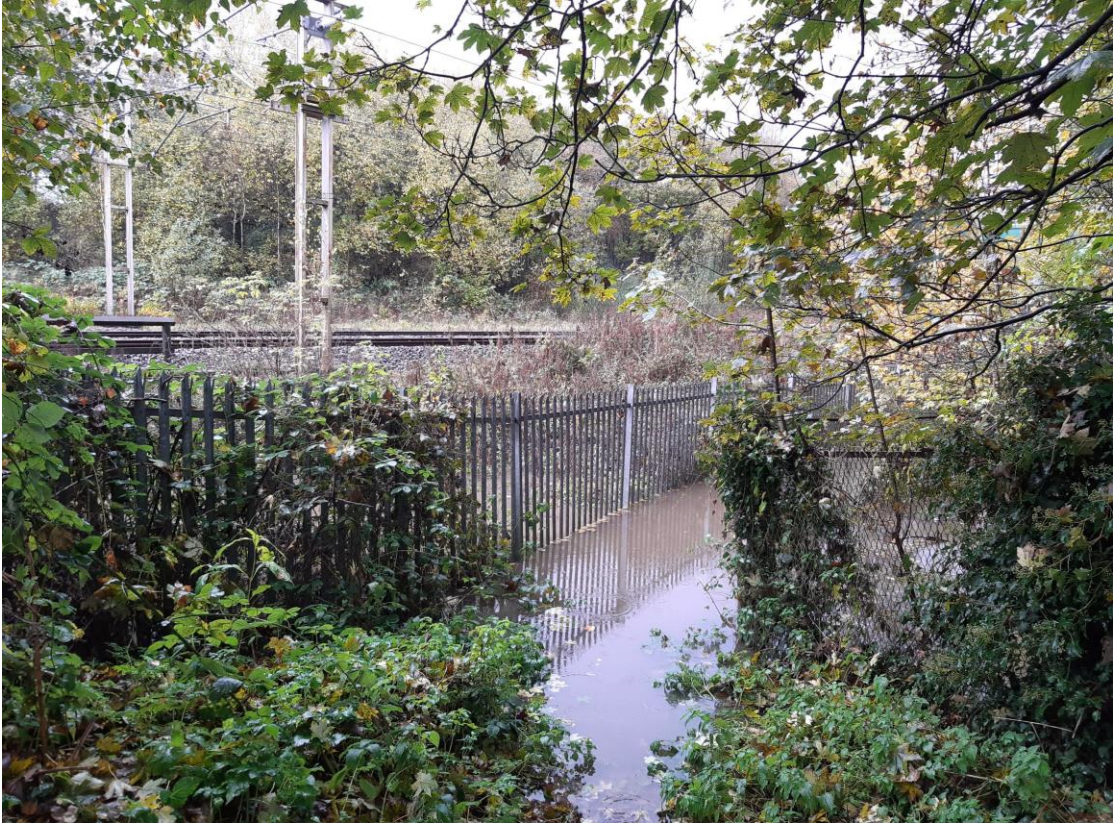
**Figure 2 - Flooding at Inlet to Network Rail Culvert (Morning 06/11/2023) Facing Downstream.**

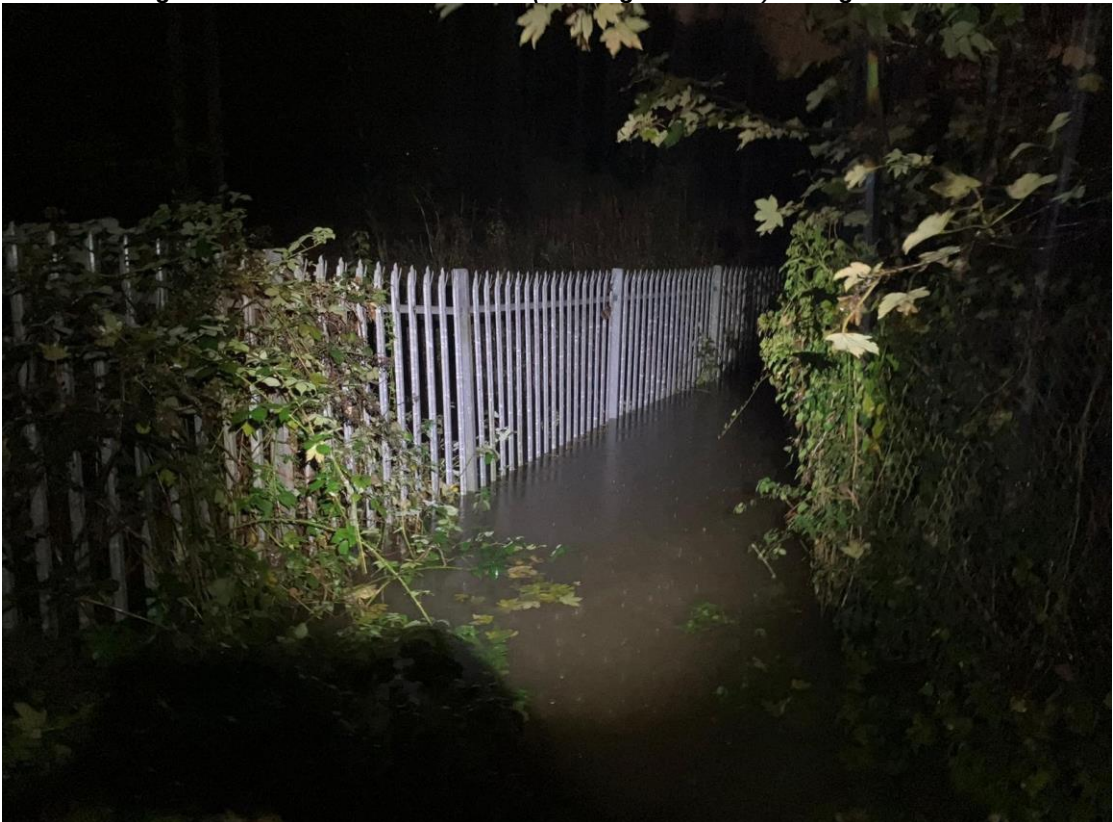
**Figure 3 - Flooding at Inlet to Network Rail Culvert (Evening 06/11/2023) Facing Downstream.**

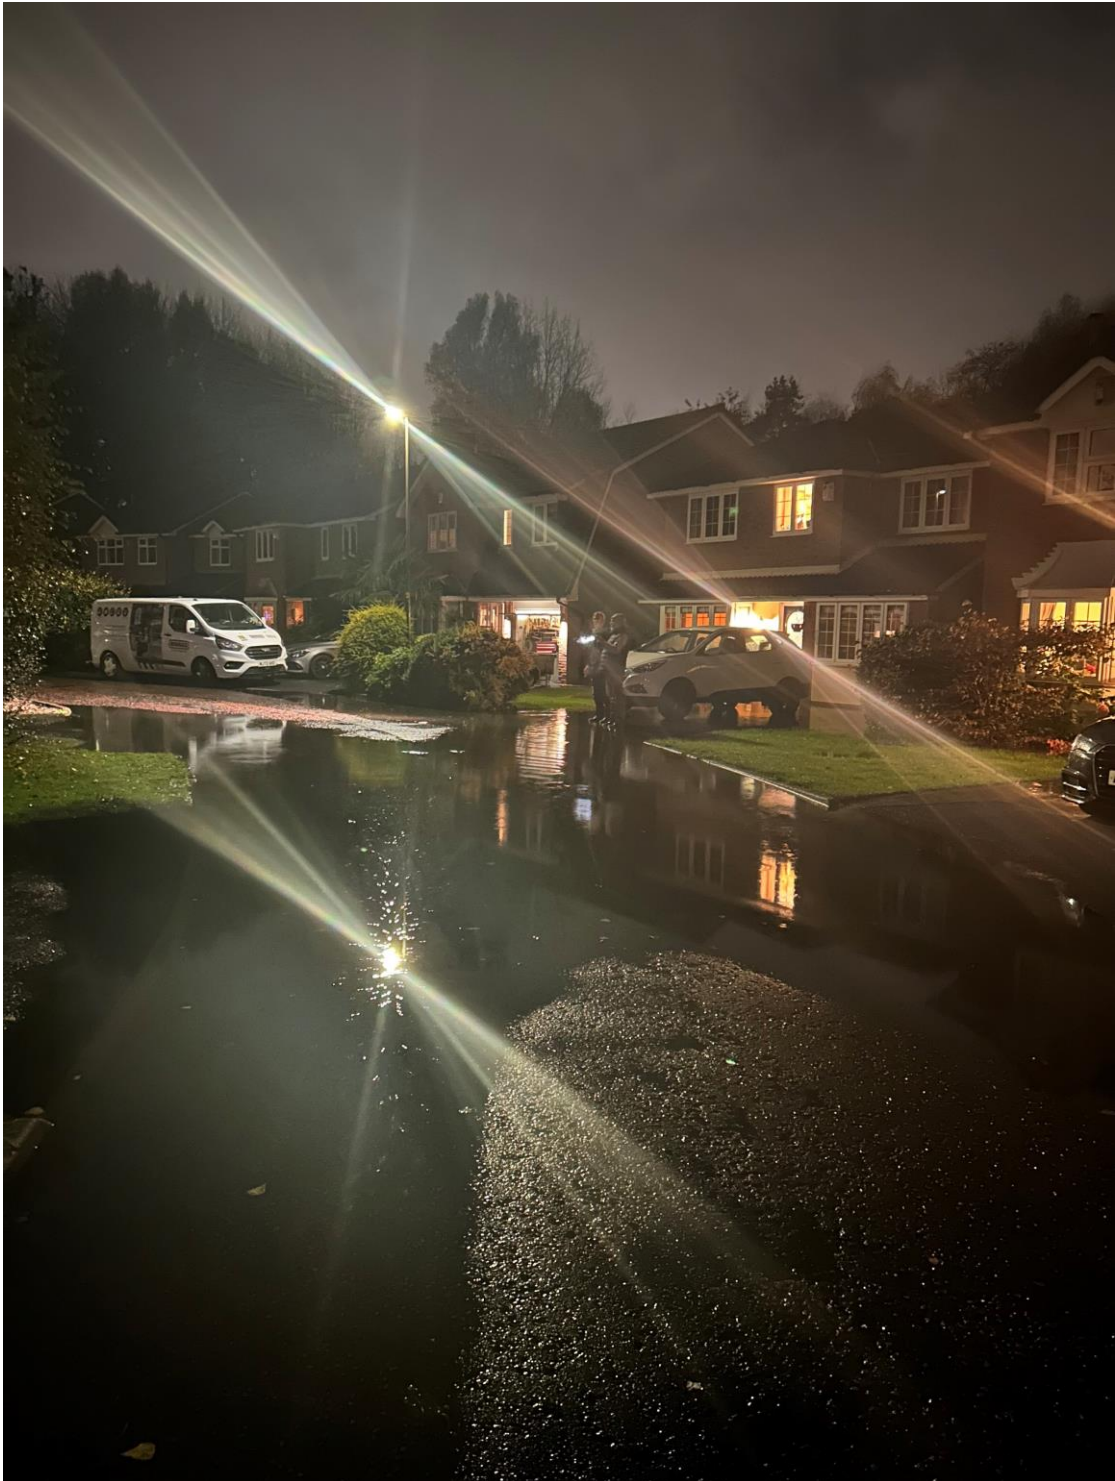
The surface water from Havenwood Road and May Tree Drive was unable to drain away as the sewer outfall into Barley Brook had become submerged. United Utilities sewer network quickly reached its capacity due to the persistent rainfall and was unable to accept any surface water from the properties or highway gullies. Ponding

on the highway eventually exceeded the height of the kerb and spread towards the properties following hours of sustained heavy rainfall. United Utilities officers that had attended site reported that the foul sewer system had become inundated with surface water causing sewage to back up onto Havenwood Road. Surface water had entered the foul sewers through the property's private drainage system resulting in the pumping station becoming overwhelmed by the additional water. United Utilities officers were on site to ensure that the pumping station remained operational and to assist with the surface water flooding. The attending UU officers also remarked that the nearby foul pumping station was running to capacity.

***Figure 4 - Surface Water Flooding on May Tree Drive (Evening 06/11/2023) approximately 7pm. Highway gullies submerged, and multiple properties flooded internally.***

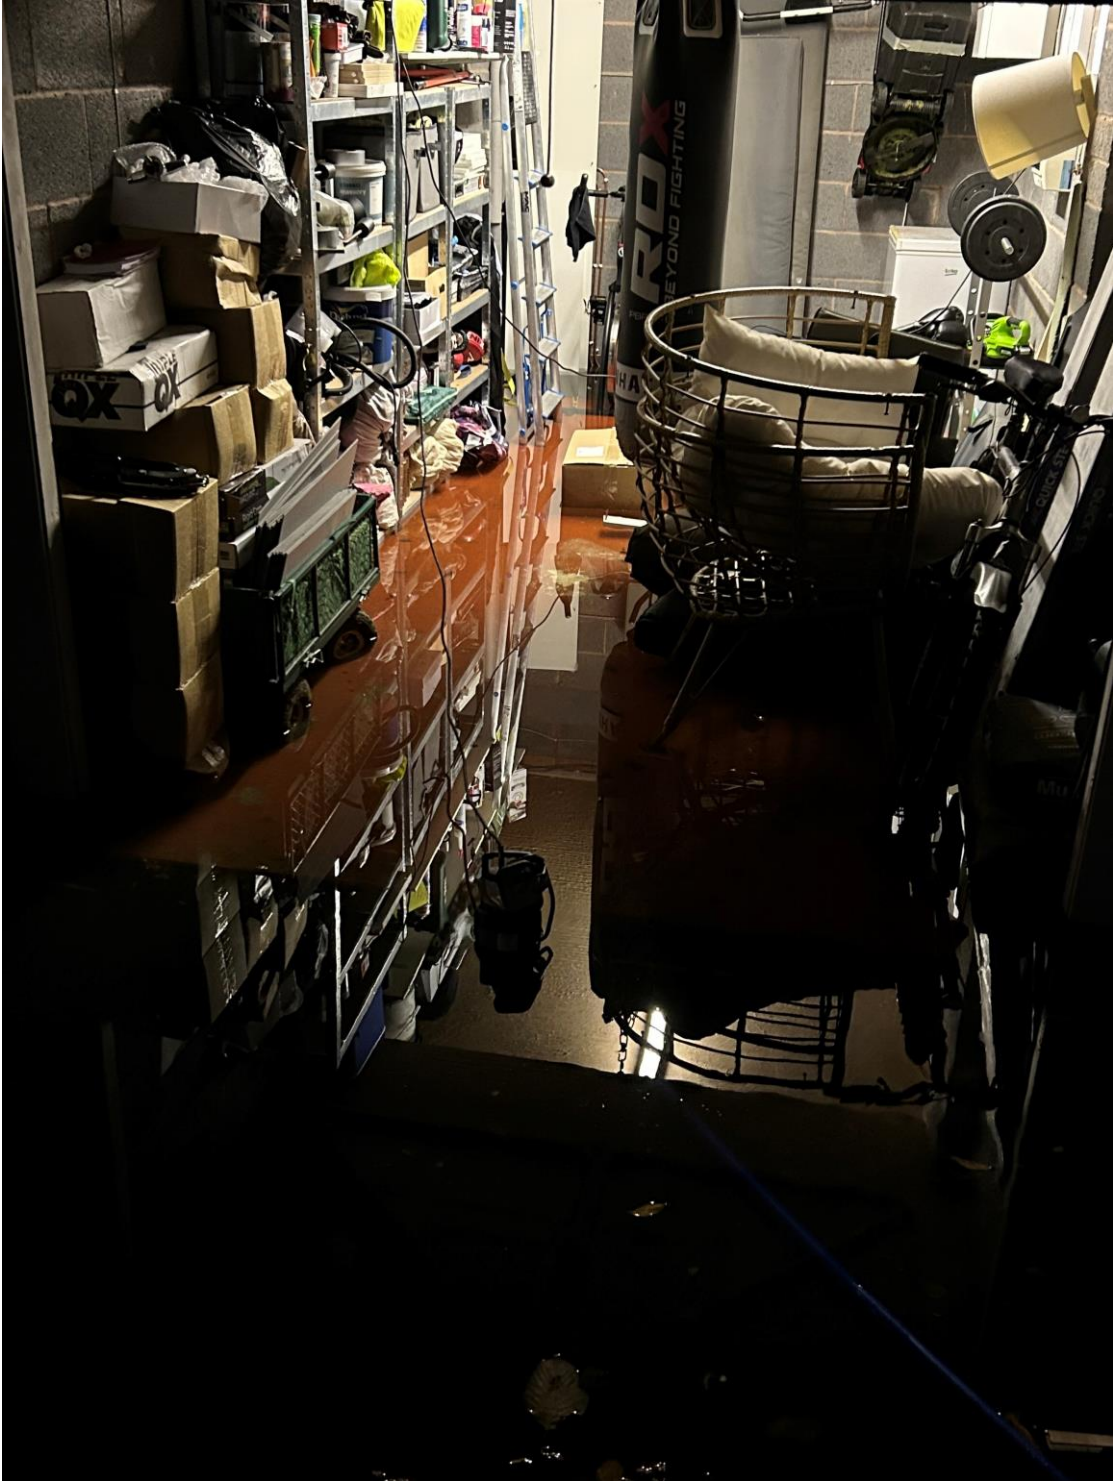
*Figure 5 - Flooding to Property on May Tree Drive (Evening 06/11/2023)*

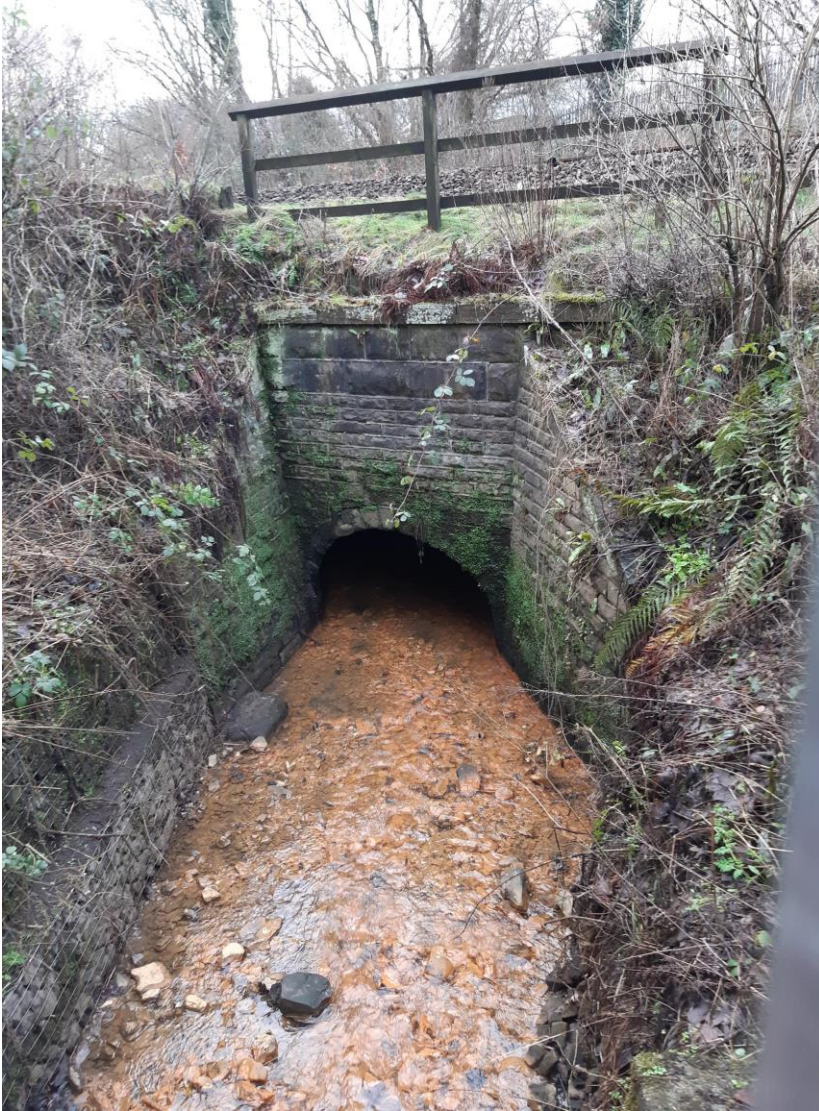
***Figure 6 - Inlet to Network Rail Culvert Under Normal Conditions. Facing Downstream. Winter 2024.***

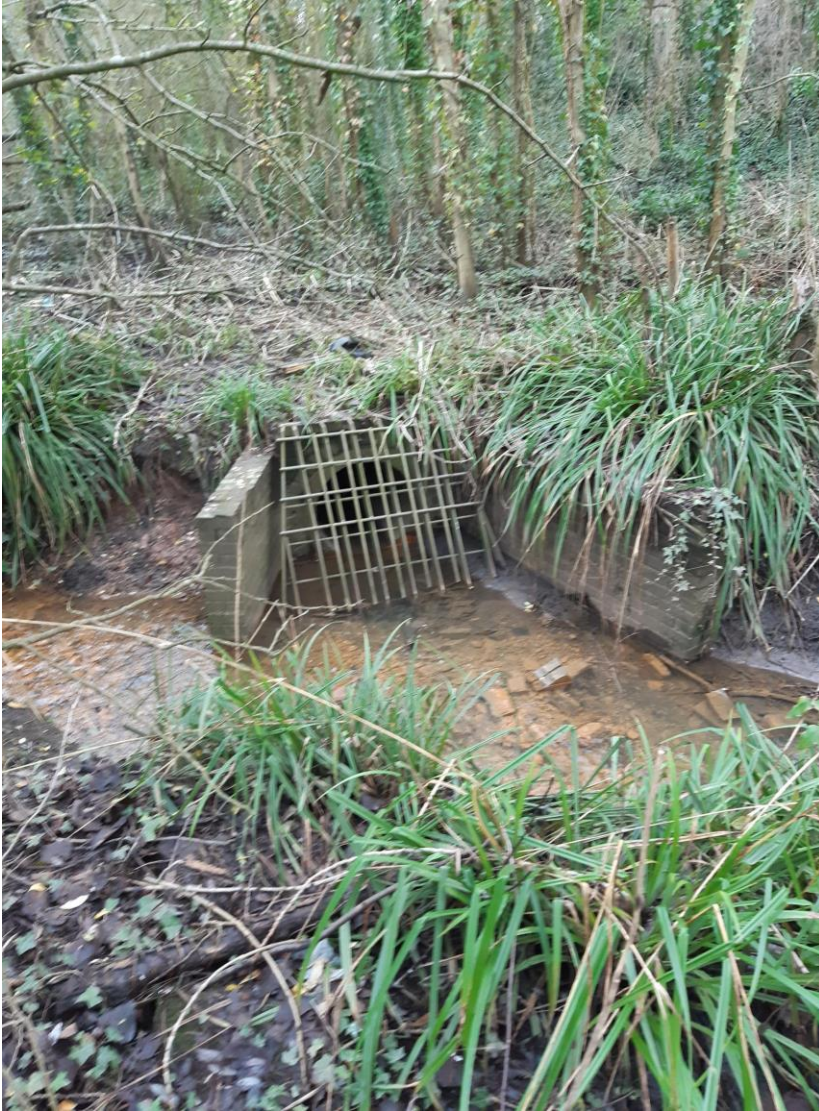
**Figure 7 - Outlet of UU Surface Water Sewer Under Normal Conditions. Upstream of Network Rail culvert. Winter 2024.**
