Lincoln Drive Section 19 Flood Investigation Report

Final Report

June 2025

Prepared for:
Wigan Council

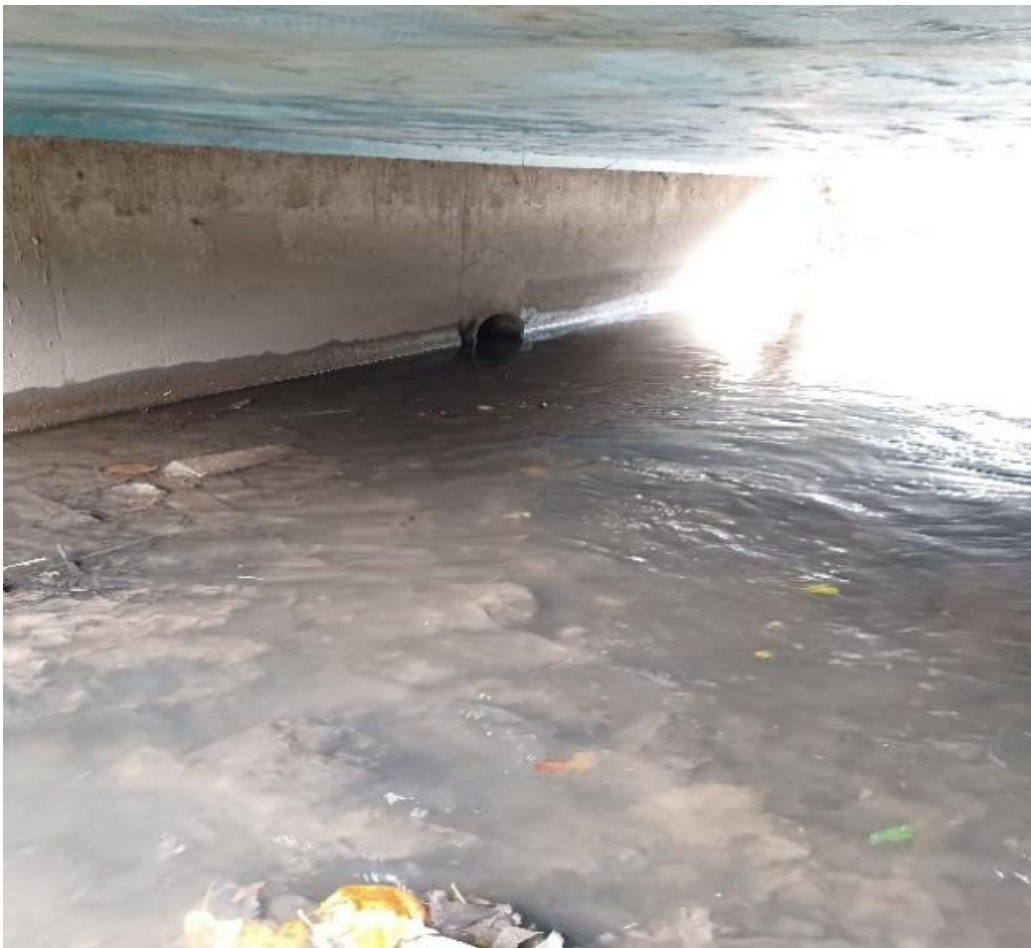
Both the culverted watercourse and the public surface water sewer discharge directly into the Millingford Brook, as discussed earlier in Section 2.4. A site investigation, conducted by United Utilities on 17 October 2024, found that the outfall to the surface water sewer was clear of obstruction. However, it was entering at invert level. This outfall shown in Figure 3-3.

Figure 3-3: Photograph of outfall into the Millingford Brook from United Utilities' network.

The inspection found that the manhole prior to discharging to the Brook, was holding some siltation. Further works have been carried out to investigate, jet, and camera the surface water sewer and highlight any operational issues prior to its discharge into the Brook.

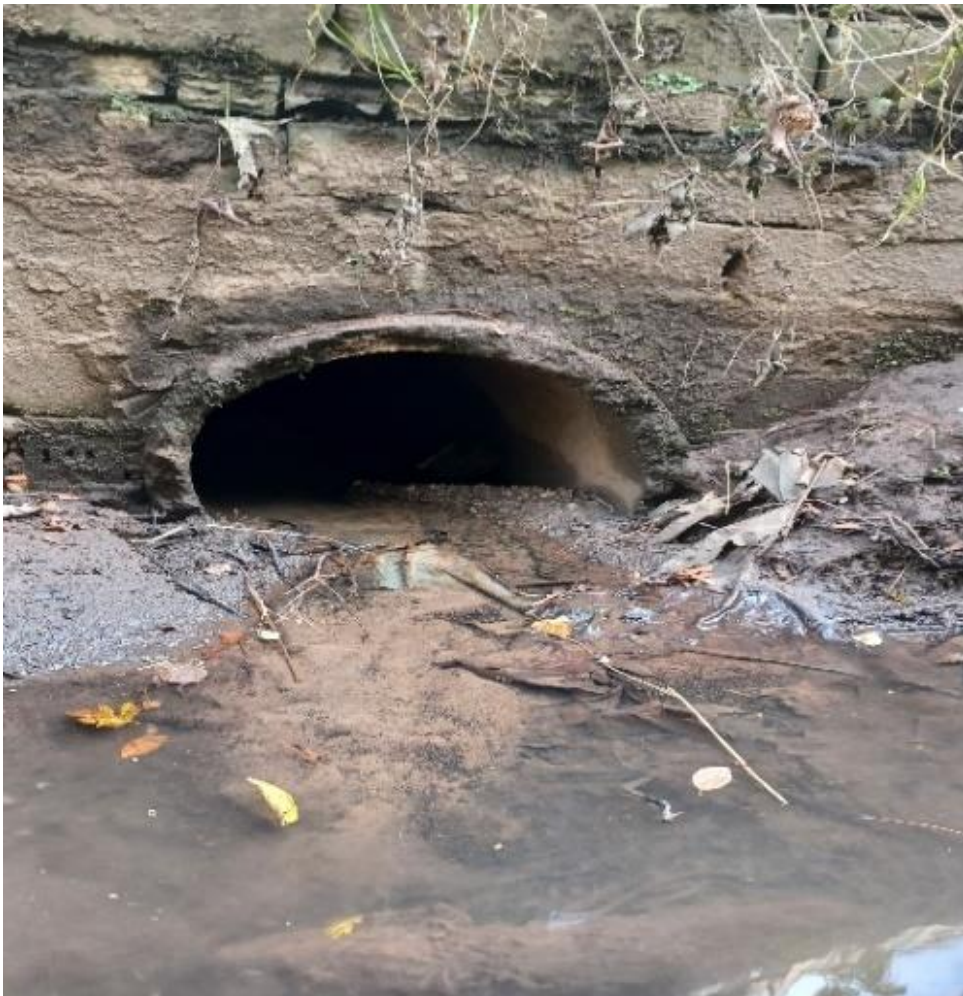
Whilst on site United Utilities also noted the culvert outfall was in a state of disrepair, see Figure 3-4. The culvert is owned by the Council's Corporate Land Management team who

Figure 3-4: Photograph of outfall of culverted watercourse.

are carrying out works to investigate the culvert and jet the system to check for any blockages or collapses.

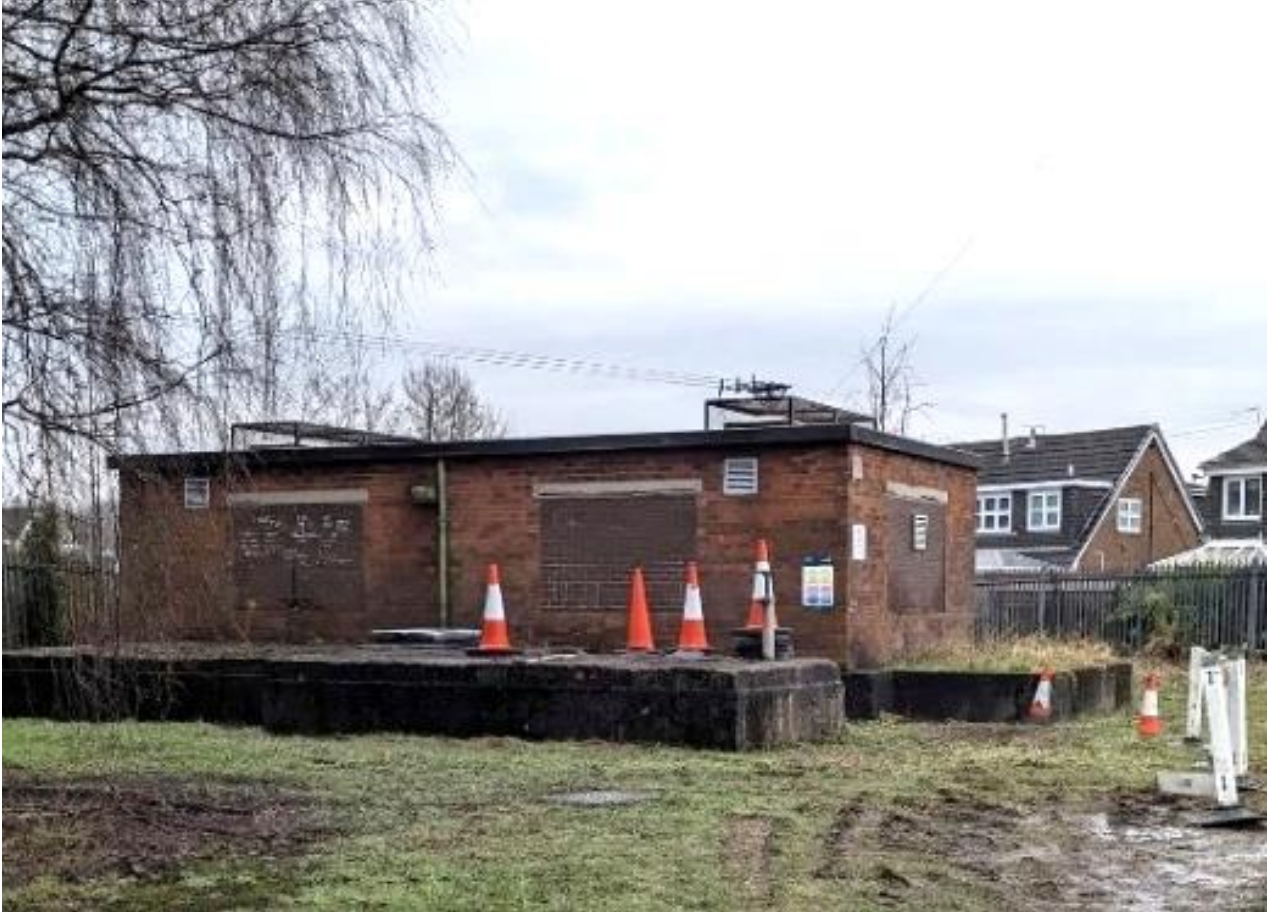
The depth of the floodwater reached the top of the concrete platform that the pumping station is built upon. Safety concerns caused Electricity North West to isolate the power supply to the wider area at 05:46 on 1 January 2025. This triggered United Utilities' Emergency Procedure, and they delivered an emergency generator. However, they could not immediately access the site to install it due to the water level. After the floodwater had receded sufficiently, the pumping station was restored to operational status at 15:31 on 1 January 2025.

Evidence provided by United Utilities suggests that whilst the pumping station did not directly contribute to the flooding, the Princess Road CSO was in operation for an extended period due to the large volumes of flood water entering the combined sewer system, as well as the loss of power to the Pumping Station, which caused flows to back up the system and spill over the CSO weir for 17 hours and 44 minutes contributing to high levels in the river.

Figure 6-2: United Utilities pumping station.

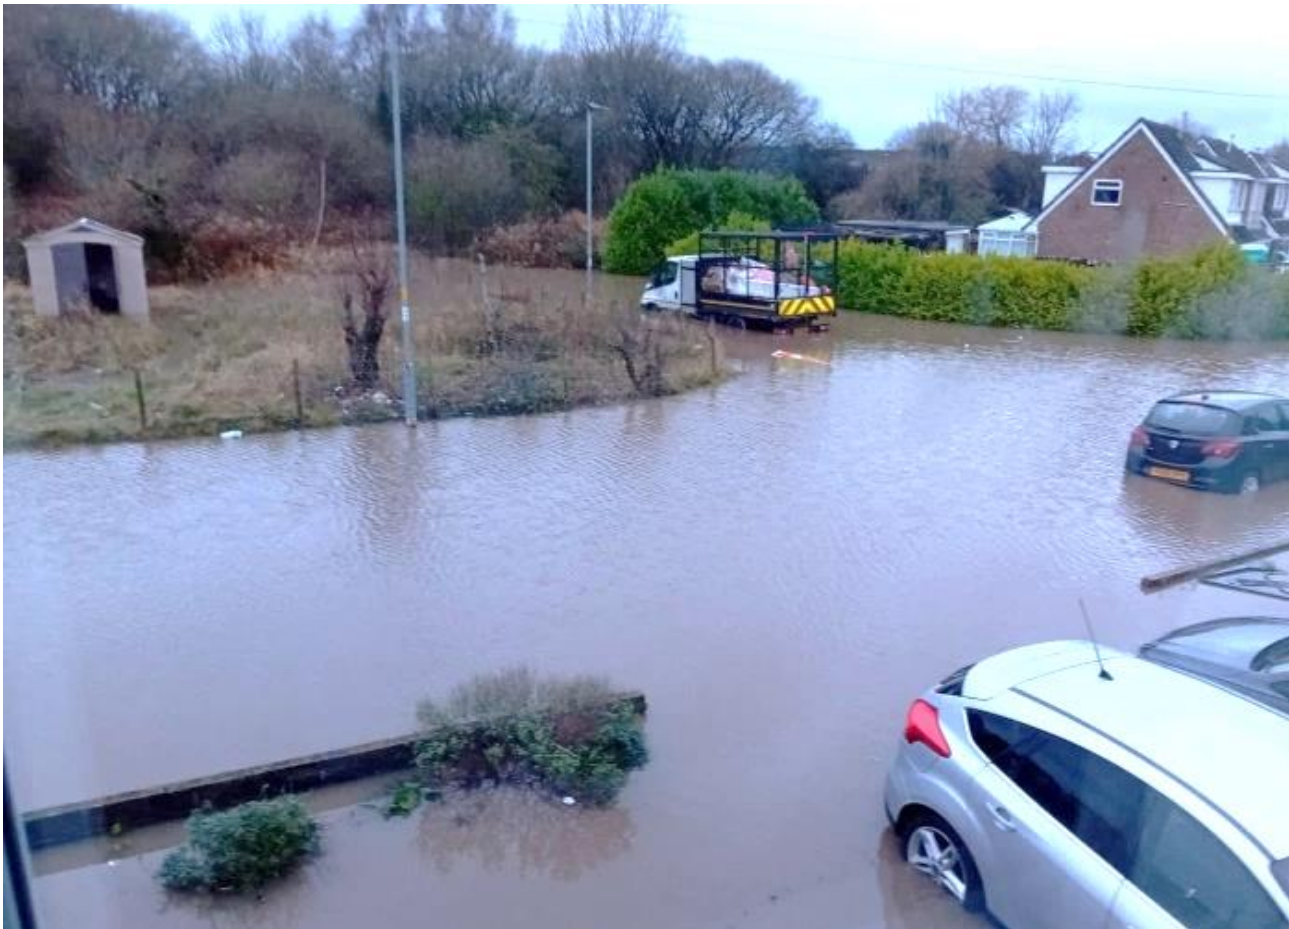
The combined fluvial and surface floodwater then flowed into the backyards and into properties along Lincoln Drive. The water also flowed between the houses on Lincoln Drive, including where there is a turning circle, shown in Figure 6-3.

Figure 6-3: Flooding on Lincoln Drive with turning circle by van (source: Lincoln Drive residents).

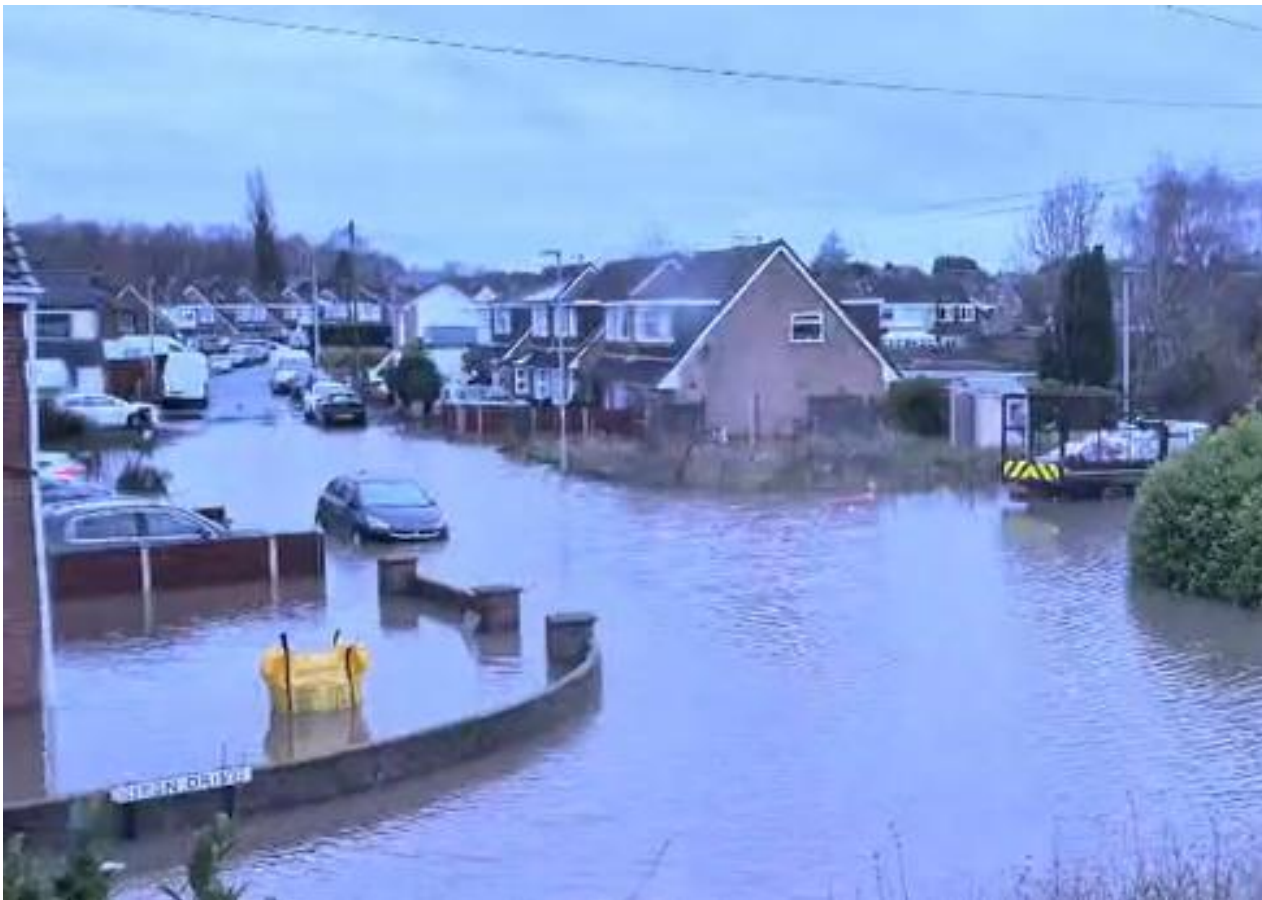
The surface water flooding from the gullies and manholes that surcharged converged with the flow from the Millingford Brook and the woodland, adding to the volume of floodwater on Lincoln Drive. This pathway of converged floodwater continued southwest down Lincoln Drive towards the bridge over the Millingford Brook, flooding more properties, as seen in Figure 6-4, and southeast onto Chester Drive causing further internal flooding. The floodwater also travelled northwards along Lincoln Drive, and southwest onto Ripon Drive, flooding several more properties both internally and externally.

Figure 6-4: Flooding on Lincoln Drive, looking southwest (source: Lincoln Drive residents).
