Open Water Safety Toolkit

March 2021

Sample Site based risk assessment 1: Amberswood

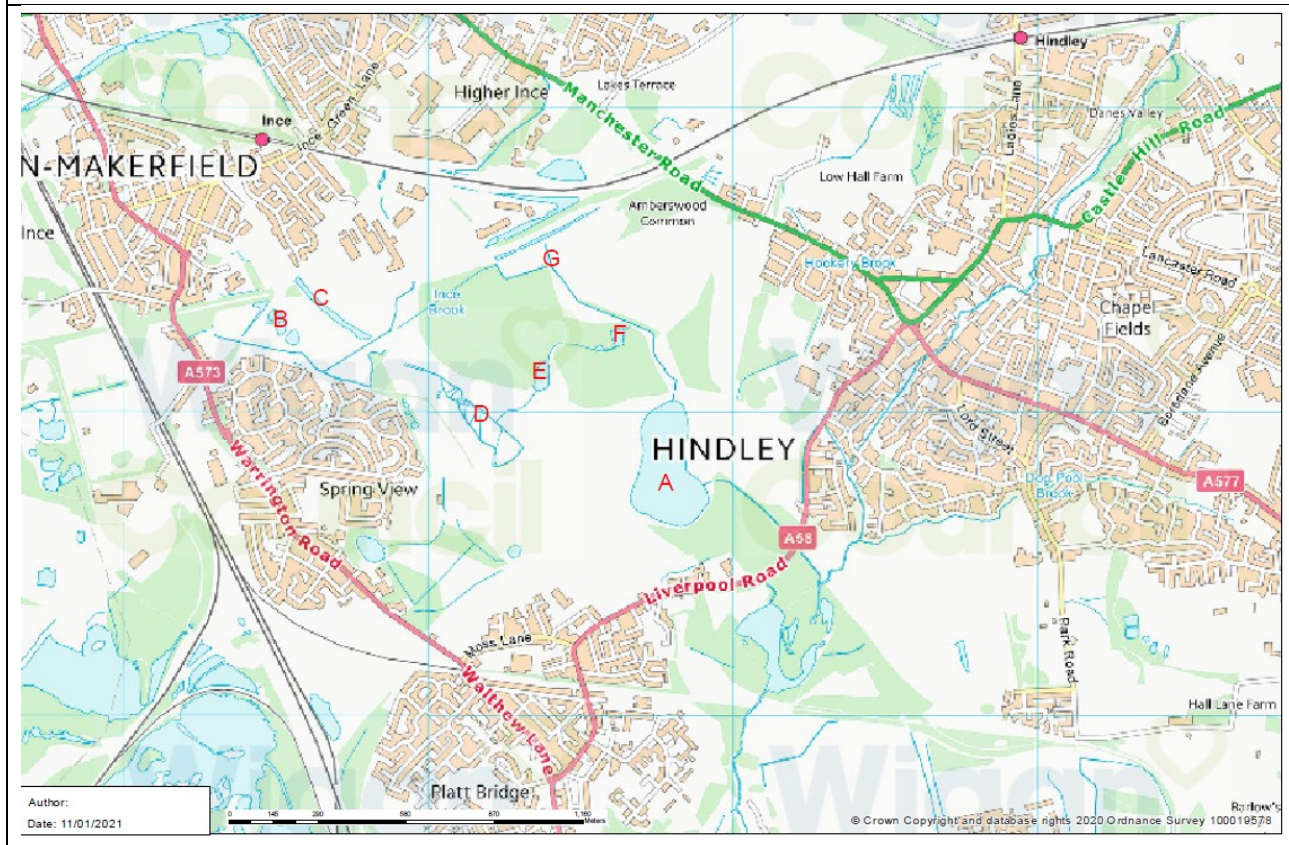
- A: Main Lake
- B: Two interlinking ponds
- C: Pond North West of site
- D: Drainage ditch adjacent mossland
- E: Shallow pond
- F: Interlinking pond
- G: Ince Brook to main lake

<p>E. Shallow pond approx. 1 metre deep with graded bank and emergent vegetation at edges.</p> <p>F. Shallow interlinking pond approx. 1 metre deep with graded bank and emergent vegetation at edges.</p> <p>G. Ince Brook to main lake is a steep sided engineered channel although usually only containing a small stream, and choked in parts by trees and vegetation.</p> <p>There are other smaller water holding features across this wetland site including ditches, scrapes and pools with shallow water.</p>
<p>Behavioural factors Risk assessment will help to determine if restricting access is practicable or desirable and it will help to identify appropriate risk control measures.</p>	<p>A. Most of the boundary has a barrier form the reedbed. However there is known activities that take place on the water. The main risk is deemed to come from unauthorised swimming , boats/kayaks, unauthorised fishing– the main control measure recommended is improved and increased signage, all around the lake shoreline at the main access points.</p> <p>B. Unauthorised fishing- the main control measure recommended is improved and increased signage at main access points for both ponds.</p> <p>C. No known activities- however signage at obvious access points would advise the public of the risk</p> <p>D. No known activities- however signage at obvious access points would advise the public of the risk</p> <p>E. No known activities</p> <p>F. No known activities</p> <p>G. No known activities</p>

falls into the water from the footpath and deep water warning signs could be added.
Type of edge The proximity of deep water to the edge	<ul style="list-style-type: none"> A. Water depth is unknown but does appear to be relatively shallow within 1 metre of the edge. B. Water in these ponds also vary – in some cases C. Water depth is unknown. From observation from the embankment the levels appear to fluctuate quite significantly near the edge. D. Water in the ditch is approx.. 1.5 metres deep. E. Shallow water at water's edge with graded bank. Water depth in pond is approx. 1.0 m deep F. Shallow water at water's edge. Water depth in pond is approx. 1.0 m deep. G. Usually contains just a small stream.
The water The accessibility of the water	See above
Known accident history	TBC – Death following kayaking accident
Evaluation of risk	<p>Low/Med/High</p> <p>A: High B: Med C: Med</p>
Further control measures recommended	TBC

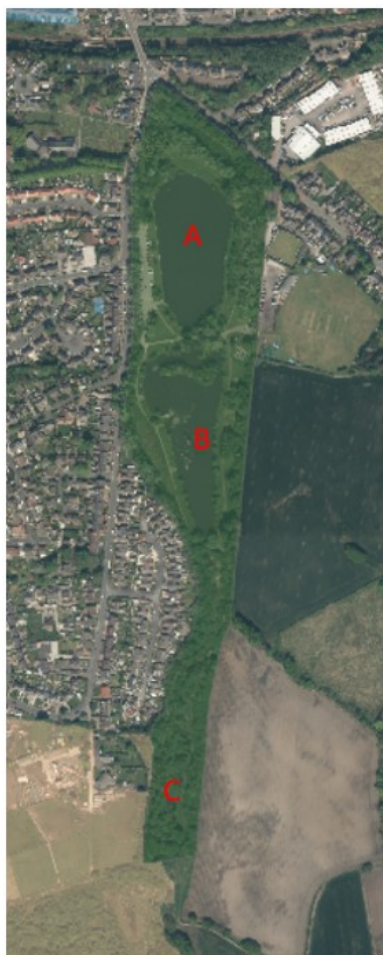
Orrell Water Park consists of two disused reservoirs (marked A and B on the picture) surrounded by woodland, with a stream running northwards from the south end (“C” in the map) and feeding into reservoir B. It is understood that Orrell Water Park was formerly Orrell Reservoir and was subject to a development scheme in the late 1970’s. The Reservoirs Act 1975 requires a ‘Discontinuance Certificate’ if reservoirs are discontinued. However, there is no evidence that such a certificate existed following research by Wigan Council and the Environment Agency (EA). EA commented: ‘The EA have searched both their paper and electronic archive back to 1997 and they can find no reference to Orrell Water Park or reservoir’.

Water depth is known to be considerable in the middle of the two reservoirs, dropping quickly from the edge – nb: there are seasonal and rainfall related variations in water levels.

Evaluation of risk	<p>Low/Med/High</p> <p>The risk rating for this open water is:</p> <ul style="list-style-type: none"> A. North Water: High B. South Water: High C. Stream: Low
---------------------------	---

Further control measures recommended	<p>Signage Repeat GMFRS information notices should be provided at suitable locations such as entry pathways, including the car park and identified high risk areas</p> <p>Swimming and/or water access is not encouraged but actively discouraged (GMFRS information signs). Where identified, the nature of water and underwater hazards should also be made clear through unambiguous signage.</p> <p>Provision of Personal Rescue Equipment PRE Personal Rescue Equipment (PRE) is located at Orrell Water Park in the form of life rings. Comments received by a Greenspaces line manager suggest that the equipment at Orrell Water Park was subject to vandalism/theft when located on adjacent land. However, there is no formal record of such behaviour. It is still perceived that such equipment would be</p>
---	--

Consideration should be given to the removal of the current PRE. Alternatively, replacement by more suitable equipment located in an appropriate position. If provided, the equipment must be subject to appropriate inspection and maintenance.

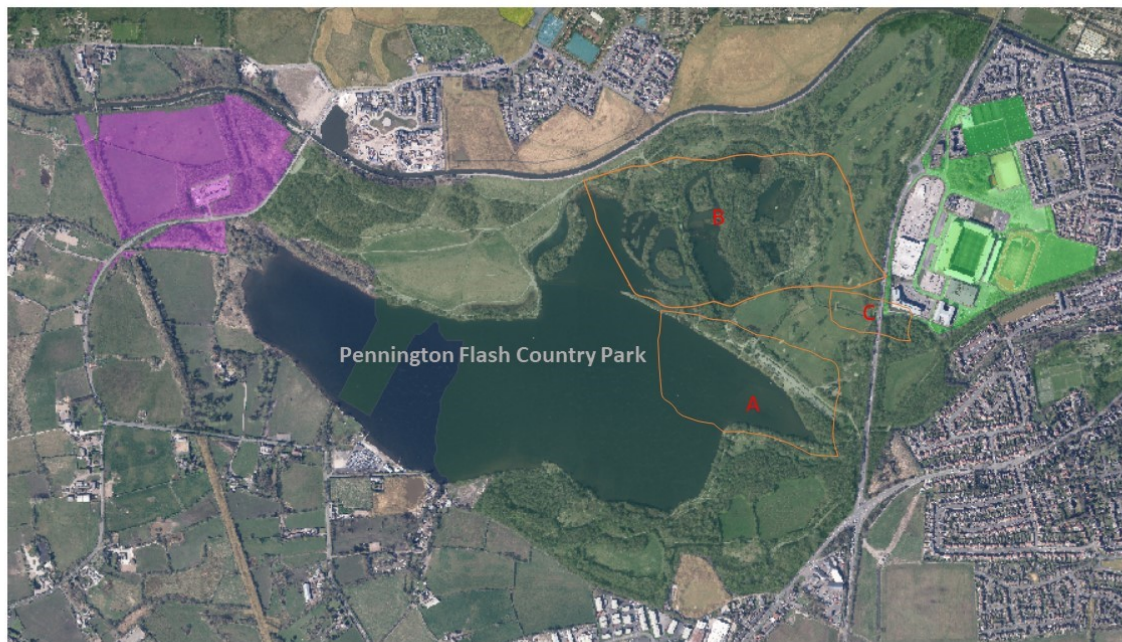
A: "Honey pot": main car park and public facilities, golf course shop, playgrounds

B: Ponds, bird hides, quiet walks, canal access

C: West Leigh Brook - across golf course and connecting with Leigh Sports Village (LSV)

<p>Environmental factors (The nature of the water) Site specific risk assessment and will take into account issues such as known swimming locations, signage, vandalism, local knowledge, etc.</p>	<p>Pennington Flash is a large destination country park, focused on the flash itself – a large water body (cover approx. 170 acres) of which approx. 1/3 is leased to a sailing club¹. In addition to the flash the park includes a number of ponds (esp on the north site) – home to diverse wildlife. A number of streams run across the site, notably Westleigh Brook. For ease of description in this document these areas have been labelled as follows:</p> <ul style="list-style-type: none"> • A: “Honey pot”: main car park and public facilities, golf course shop, playgrounds • B: Ponds, bird hides, quiet walks, canal access • C: West Leigh Brook - across golf course and connecting with Leigh Sports Village (LSV) <p>H. The sole vehicle access road at the south end of the site gives access to a large car park on the NE shore of the flash. All main facilities – toilets and now disused visitor centre, playgrounds and the golf course shop and entrance – are next to this car park, as is a catering van concession. These factors all mean footfall is highest in this section of the park. This is where large events concentrate – notably the yearly ‘Ironman’ competition: a rare occasion where swimming in the flash is expected. Access to the water is open around that most of the shoreline – there are some sections where vegetation constitutes a barrier, intentionally or otherwise. Note that Blue & Green Algae is seasonally present in the water.</p> <p>I. This section encompasses a number of water bodies of varying depths, rich in wildlife as it offers suitable habitats for a number of species. Some but not all these water bodies have fences or vegetation barriers, but in many cases access is possible and there is evidence of footfall on the water’s edge.</p> <p>J. Westleigh Brook runs across the north side of the site – shallow for the most part but grows deep (5ft – 6ft drop) in a 300yd section across the golf course, with 3 footbridges crossing it.</p>

<p>The water The accessibility of the water</p>	<p>See above</p>
<p>Known accident history</p>	<p>TBC – there is anecdotal evidence of accidents but no record of recent fatalities – the flash is used by the sailing club, events such as Ironman are held.</p>
<p>Evaluation of risk</p>	<p>Low/Med/High</p> <p>A: High B: Med C: Med</p>
<p>Further control measures recommended</p>	<p>TBC</p>
