## 4. Character and appearance

### 4.1 Identification of Character Areas

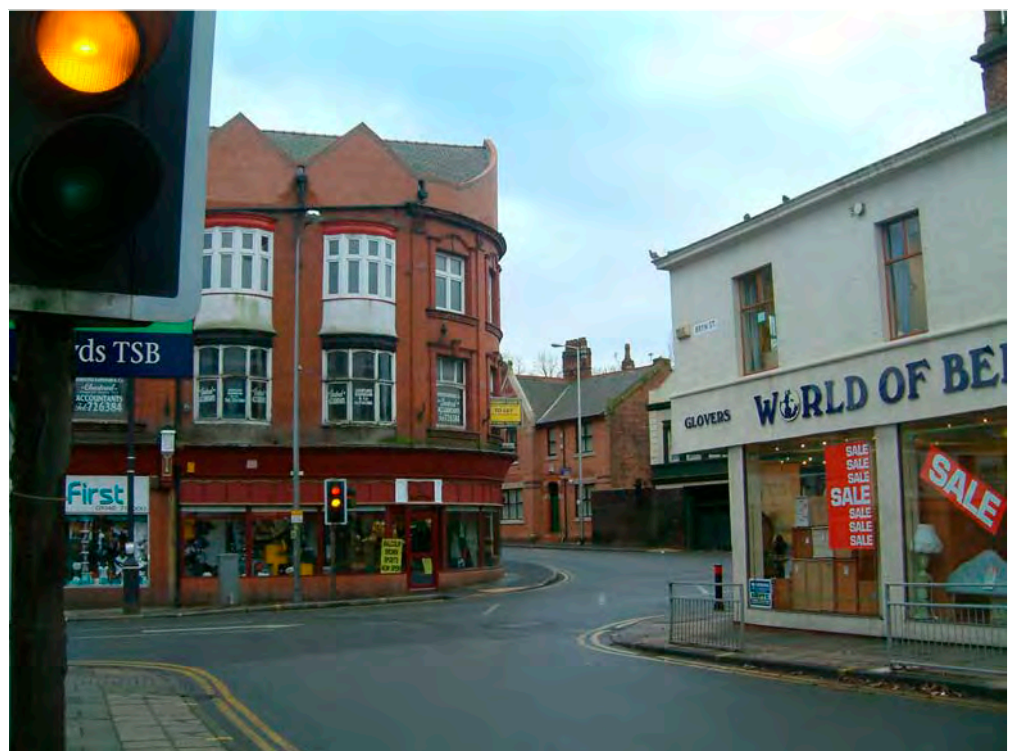
- The tight off-set junction with Warrington Road and Bryn Street joining Gerard Street is particularly defined by the higher Cooperative building and the important group of shops, no's 70-74 Gerard Street.

*View of off-set junction at southern end of Gerard Street.*

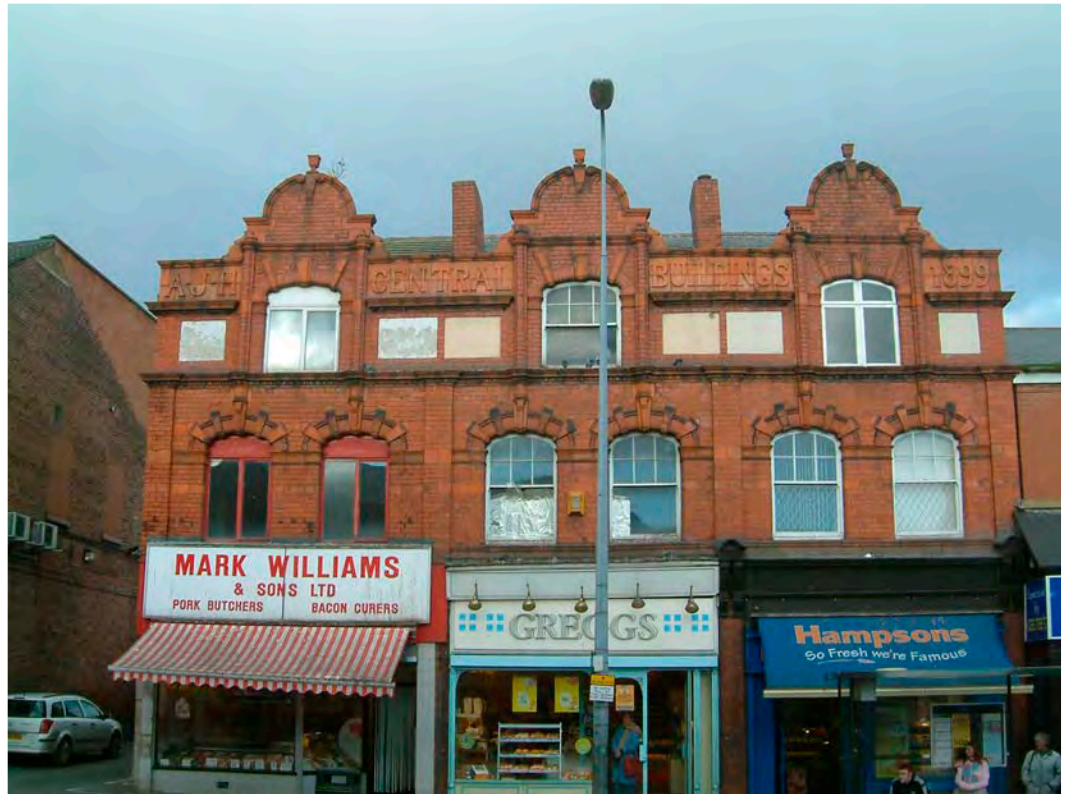
*View of Central Buildings, 1899*

- Central Buildings 1899 and Bridge Foot House 1900, both with ground floor retail use, have extravagant brick and terracotta detailing, especially along the parapet line. Bridge Foot House has a turret and cupola on its corner.

The difficult market conditions resulting from the economic downturn and other competing locations has in a number of cases led to poor maintenance, inappropriate repairs and further loss of heritage detail. An example is the fenestration on no.28 Gerard Street, on the left of the three Central Buildings 1899, where the loss of the original glazing pattern detracts from the qualities of the whole historic grouping.

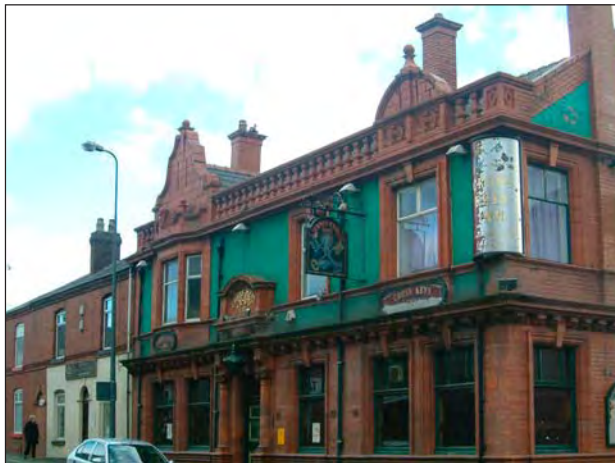
- Cross Keys public house - 1900
- Red Lion public house - 1893
- Bridge Foot House - 1902
- No. 45 Gerard Street – an original shop front and pedestrian passage linking to A Court terrace housing - mid C19

*Cross Keys public house*

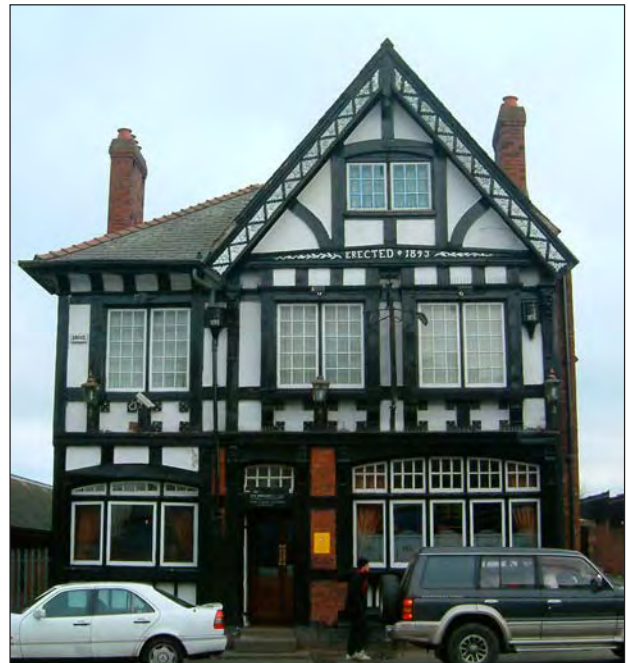
*Red Lion public house*

- The Red Lion 1893 and the Golden Lion Hotel 1905, both display black and white mock timber details above a brick ground floor. The Golden Lion also has terracotta facings to the ground floor bay windows and faience to the doorway.

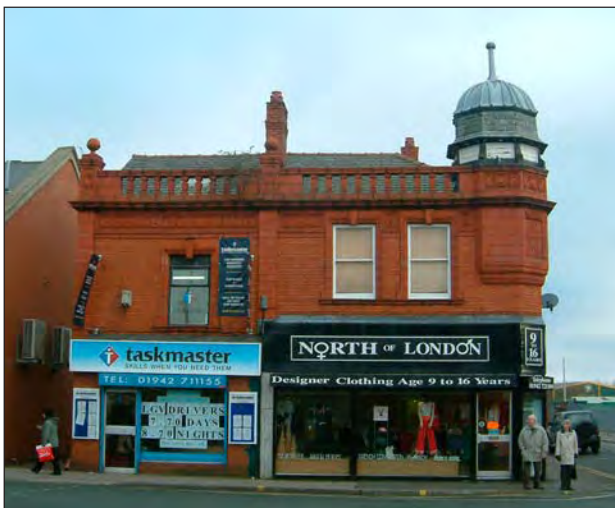
*Bridge Foot House*

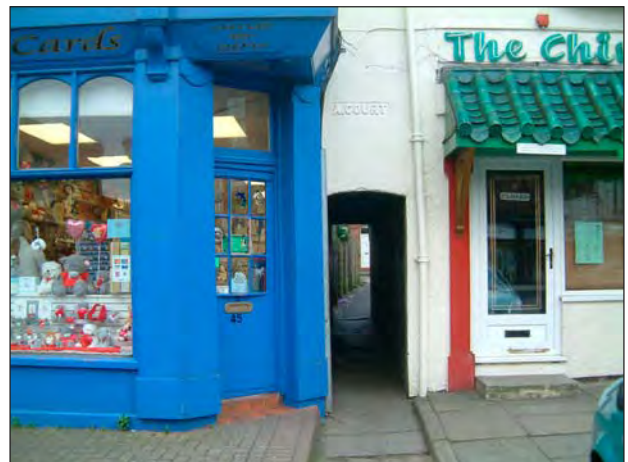
*45 Gerard Street*

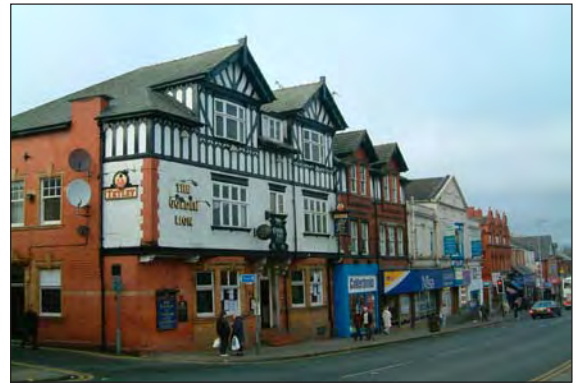
- The length of buildings on the north side of Gerard Street including the Palatine Buildings 1863, Commercial Buildings 1876, the Golden Lion Inn, the Gerard Arms and Central Buildings 1899 – no's. 24-68 Gerard Street.

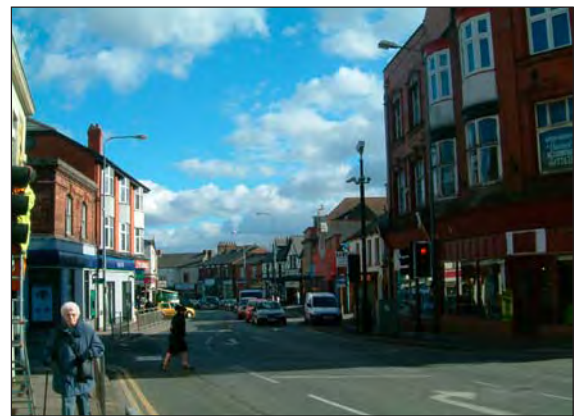
- The buildings on the south side of the bend of Gerard Street from no's. 43-63 including traditional brick shops and mock timber frontages.

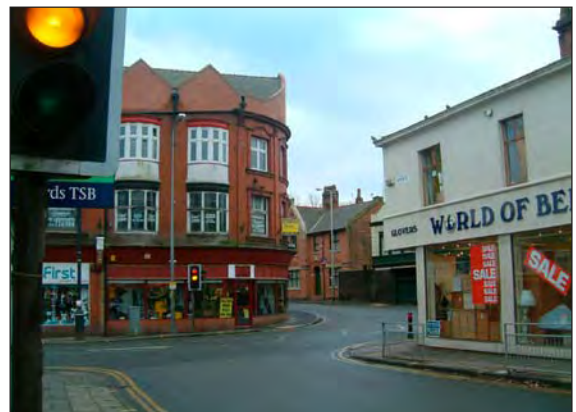
- The buildings on the off-set junction of Warrington Road/Gerard Street – the Cooperative Hall, the King's Arms Inn, 2 Liverpool Road and 70 - 74 Gerard Street which provides an important end to the view north along Warrington Road.

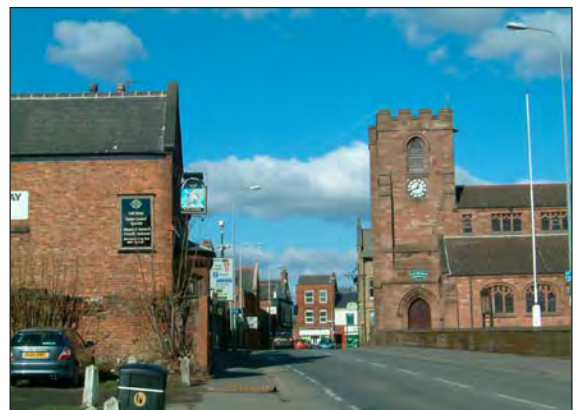
- Buildings along the northern end of Warrington Road – the Police Station, the Chapel, the two groups of shops and houses (Church View 1894) and the Angel inn on the west side, and the Fleece inn on the east side with its rear stable building facing Butchers Lane.

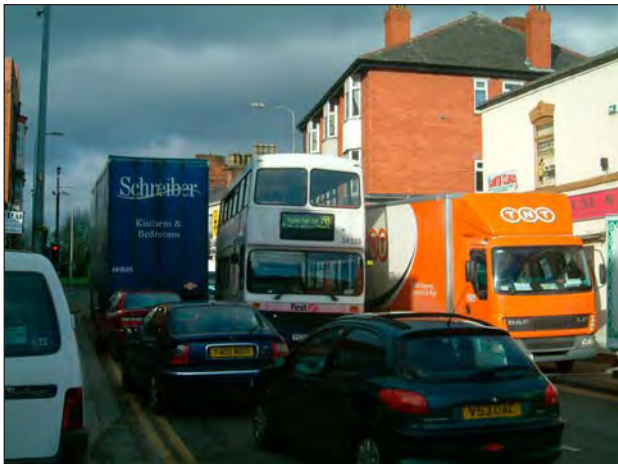
The other significant negative factor is the vehicular impact of through traffic – especially the numerous heavy lorries. Not only does this erode the experience for shoppers who wish to hold a conversation or try to cross the road, but it detracts from the townscape qualities and the opportunity to appreciate the historic buildings. The resulting public realm is of poor quality with a wide road and inappropriate pedestrian surfaces and street furniture for this attractive heritage townscape.

Traffic congestion on Gerard Street and on the pavement .

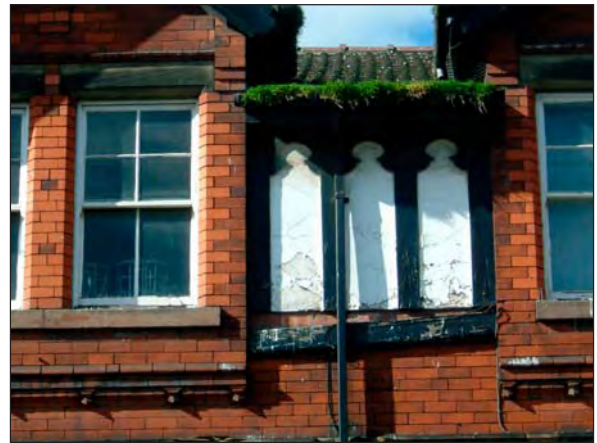
Poor maintenance on Gerard Street.

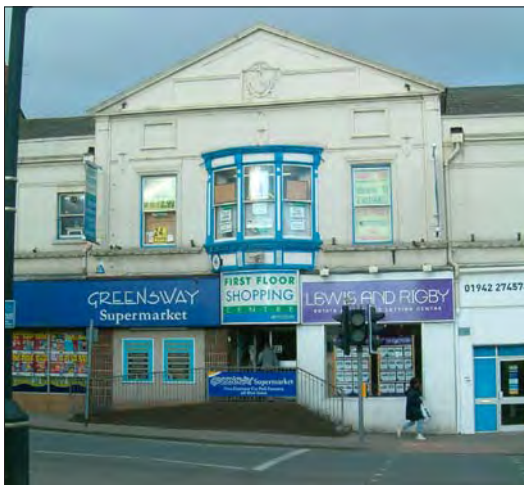
- The Gerard Arms Hotel previously was the grandest building in Ashton. Mainly built in brick it had two ground floor bays with balconies above and one central first floor bay. The mullions and details were in stone topped by a large carved frieze with the name and crest. The contrast with the basic painted building of today with atrocious shop signs is particularly sad (see past and present photographs).

There are numerous examples of unsuitable materials and designs with unfortunate loss of heritage shopfront detailing and signage. The most dramatic example is the changes to the front of the previous Gerard Arms with the loss of ground floor bays, to accommodate the conversion to the Greensway shopping centre and supermarket. See photographs showing the use of the building as a hotel and the current changes.

Present day Gerard Arms Hotel

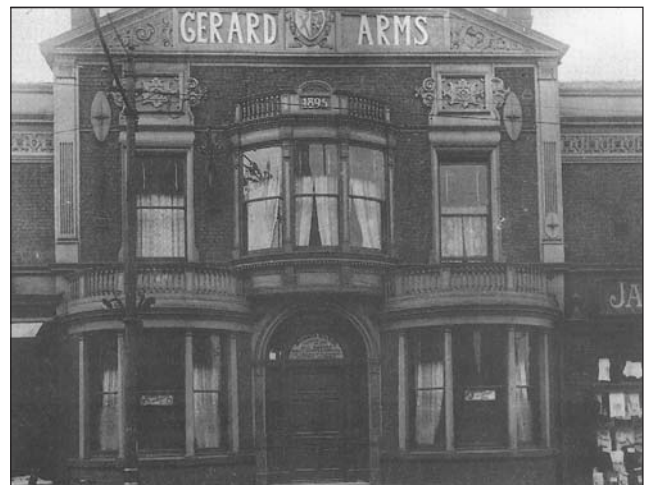
Gerard Arms Hotel as it was in 1920's .

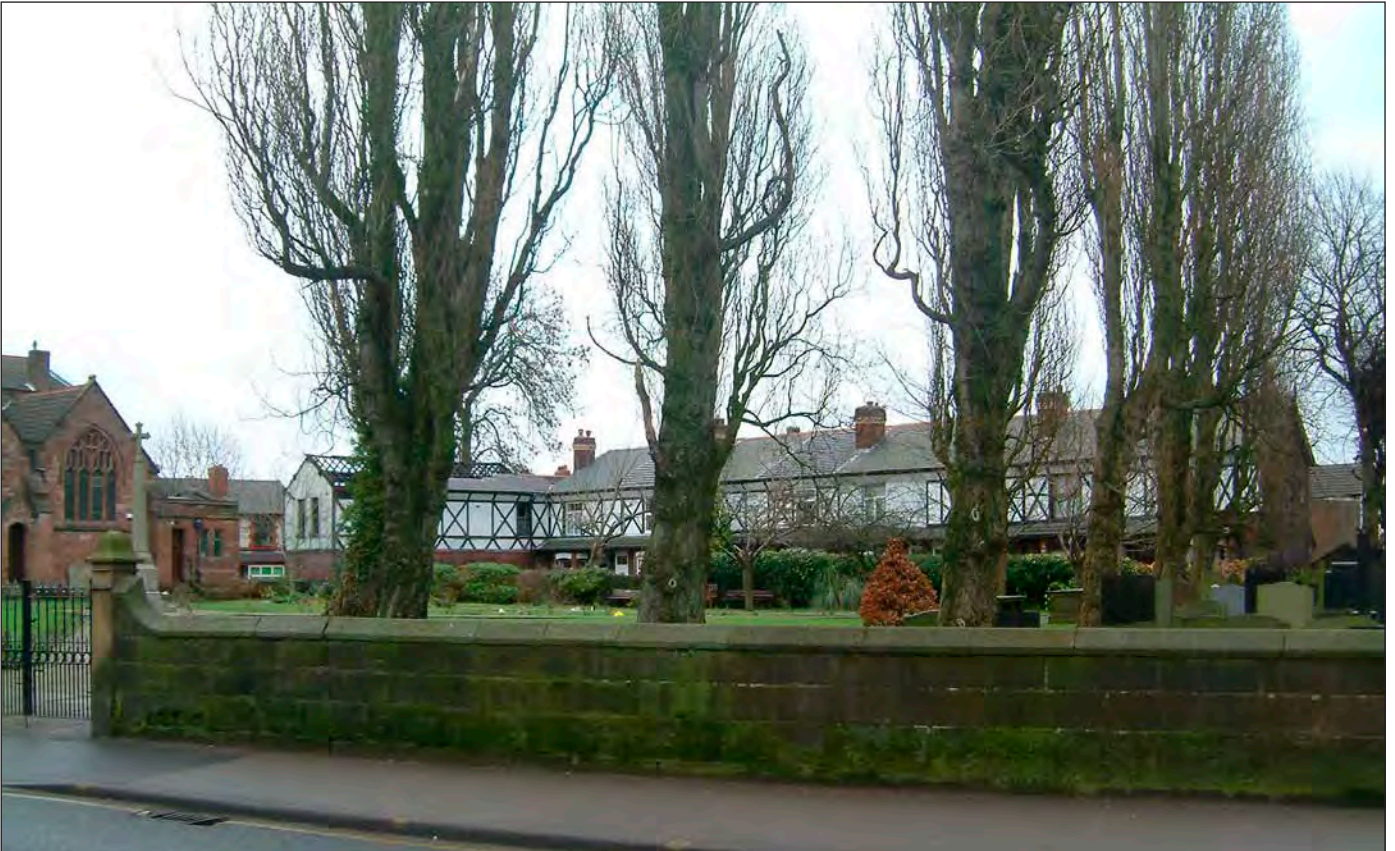
*St. Thomas's graveyard*

St Thomas's graveyard is bounded by a low stone wall which enables views from the Warrington Road of the side elevation of the church. Tall poplar trees reinforce these edges and provide structure within the graveyard by lining key pedestrian routes and framing the views of the church.

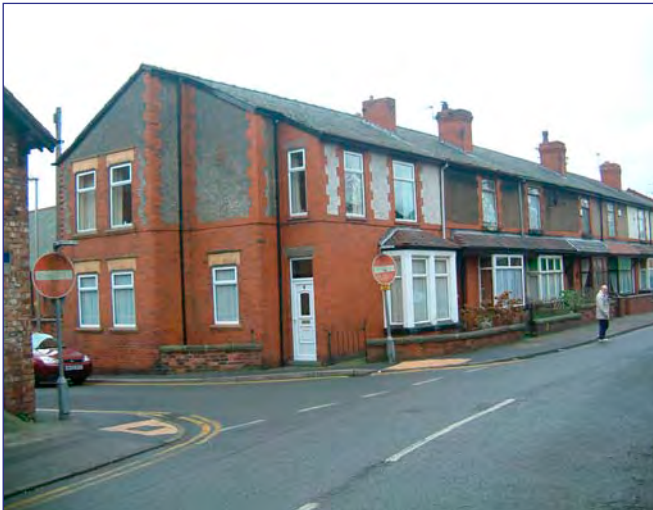
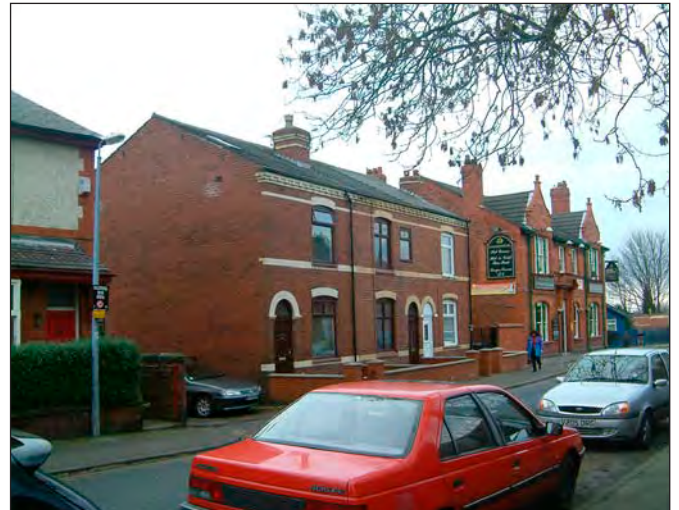
*Examples of terrace housing on heath road.*

The predominant materials are brick with slate roofs. The earliest terrace in A Court is a very simple construction and design with basic three dimensional brick details, and the later properties display more brick detailing and decoration and in the case of 1-13 heath Street bay windows and rendering. The striking L-shaped terrace around the graveyard, Church Terrace, has rendered first floors with mock timber cross framed black boarding as decoration. A later terrace on Heath Road, facing the rear of St Thomas's, was probably designed with first floor rendered panels as decoration.

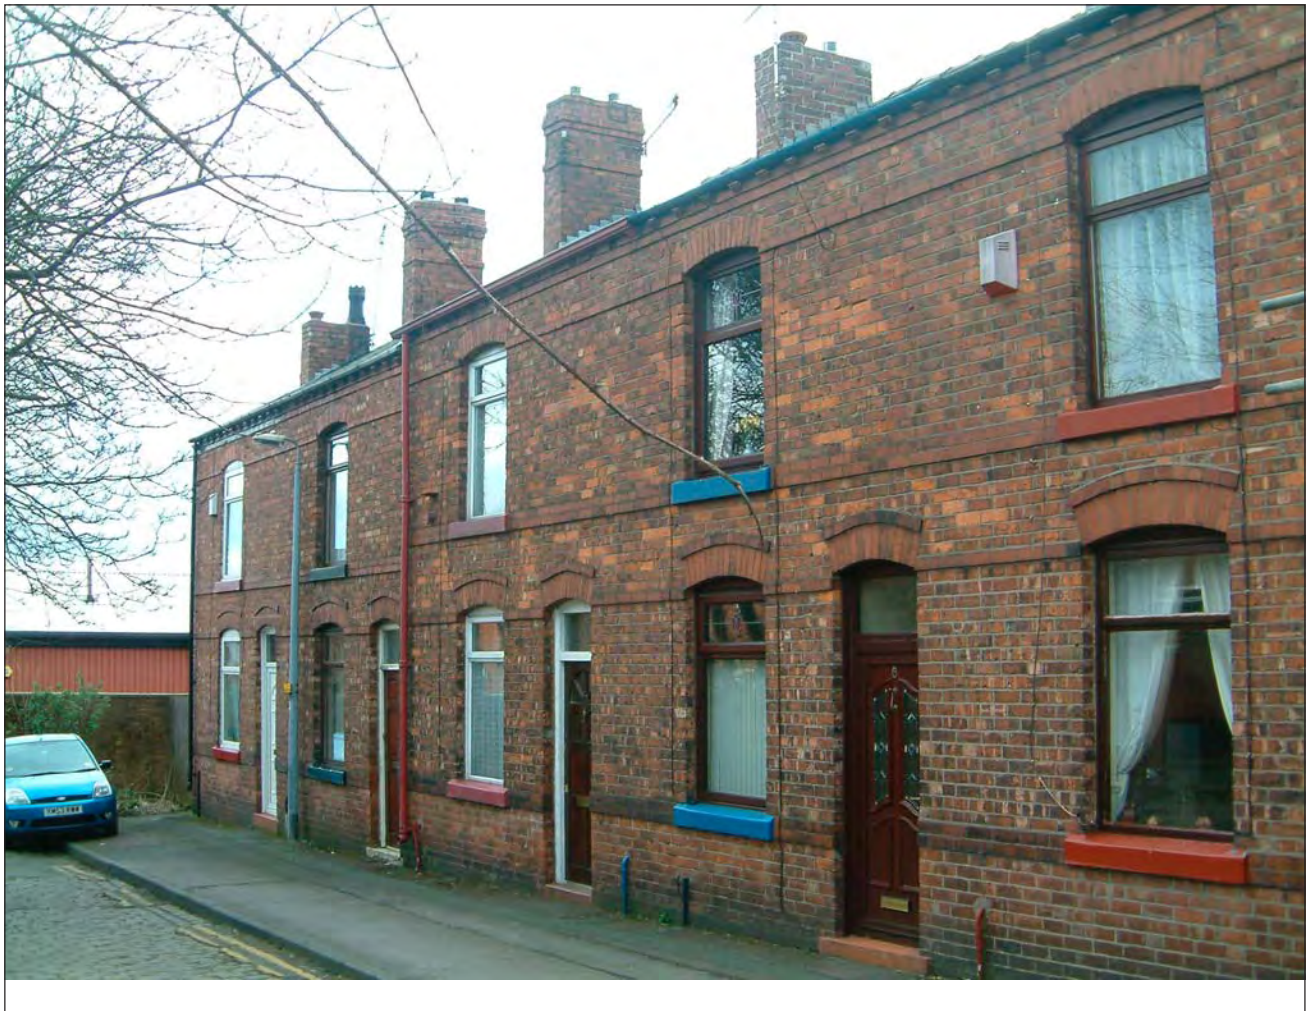
In particular, it is the widespread inappropriate alterations and replacements that are changing the heritage character of the area – the replacement of traditional windows and doors; the removal of brick detailing, chimney pots and stacks; the use of pebble dash and other non heritage wall finishes; the removal and replacement of boundary walls and railings; and the introduction of satellite dishes.

*A Court terrace with replacement doors and windows detracting from the original brick detailing.*

Together these changes have a significant impact on the overall heritage townscape and it is important to reverse these trends in order to retain the traditional character of the area.
