Lilford Park Section 19 Flood Investigation Report

Final Report

Prepared for:
Wigan Council

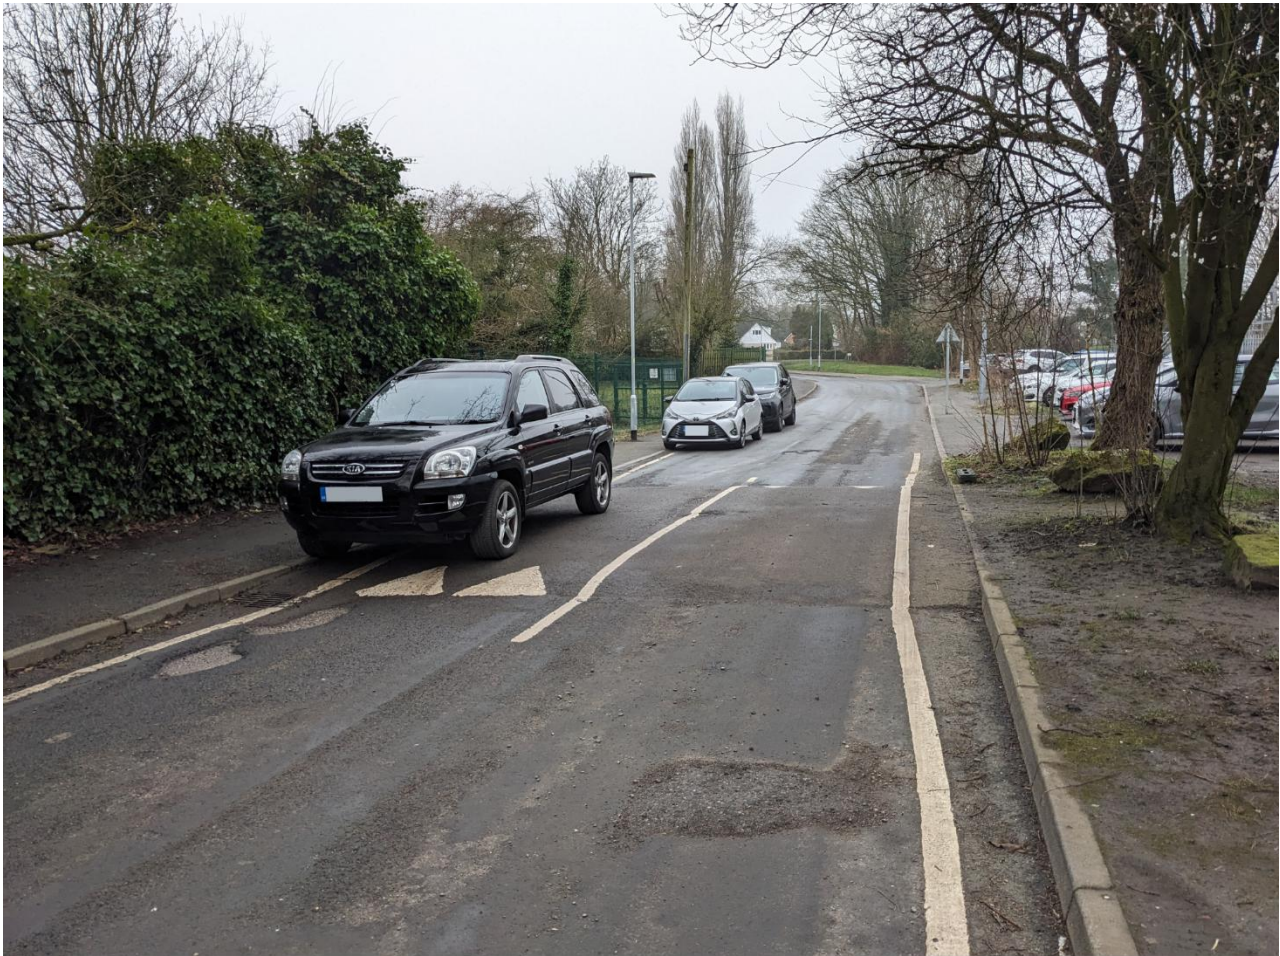
Figure 3-5: Speed table on Elmridge (Source: JBA Consulting).

The Council obtained funding to improve road drainage on Elmridge after the 26 December 2015 flood event. This included lowering the footpath and constructing a speed table, shown in Figure 3-5. The speed table was added to direct initial surface water run-off and

spills from the storage reservoir back into Atherton Lake/Lilford Park Brook, immediately downstream of the culvert under Elmridge.

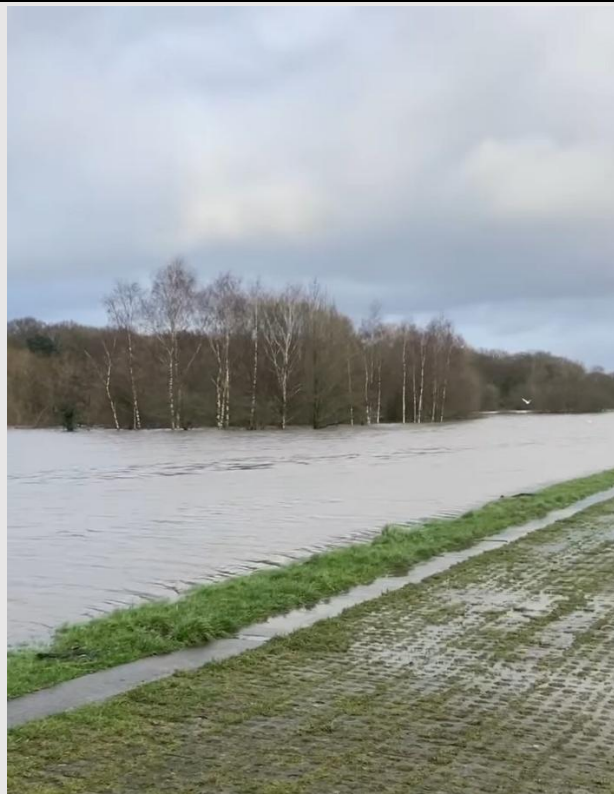
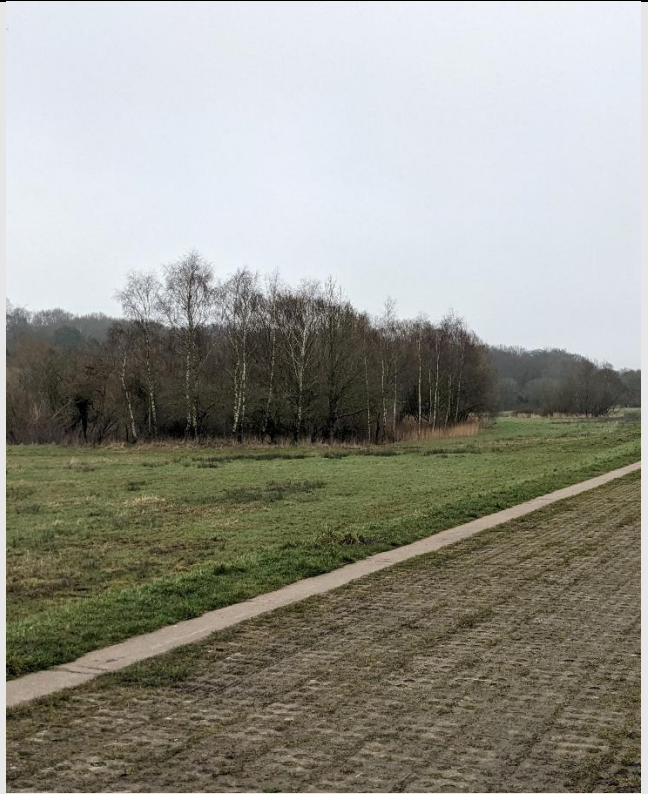
The closing of the sluice gates led to water being stored in the reservoir. Photographs 1 and 2 compare the flood storage reservoir during and after the event, showing when it was actively holding floodwater and when it was empty. However, on 1 January 2025 there was too much rainfall for the system to manage, and the flood storage reservoir exceeded its design capacity. Water overflowed both of the spillways into the park and adjacent residential area, discussed further in the next section (Section 6.2). From 17:30 on 1 January 2025, the sluice gates started open again and continued to open and close according to their design parameters to release water from Atherton Lake flood storage reservoir. Both sluice gates were back in their pre-event open positions at 04:45 on 2 January 2025.

Photo 1: Atherton Lake flood storage reservoir, being used during the event
(Source: Lilford Park residents).

Photo 2: Atherton Lake flood storage reservoir after the event, not being used
(Source: JBA Consulting).

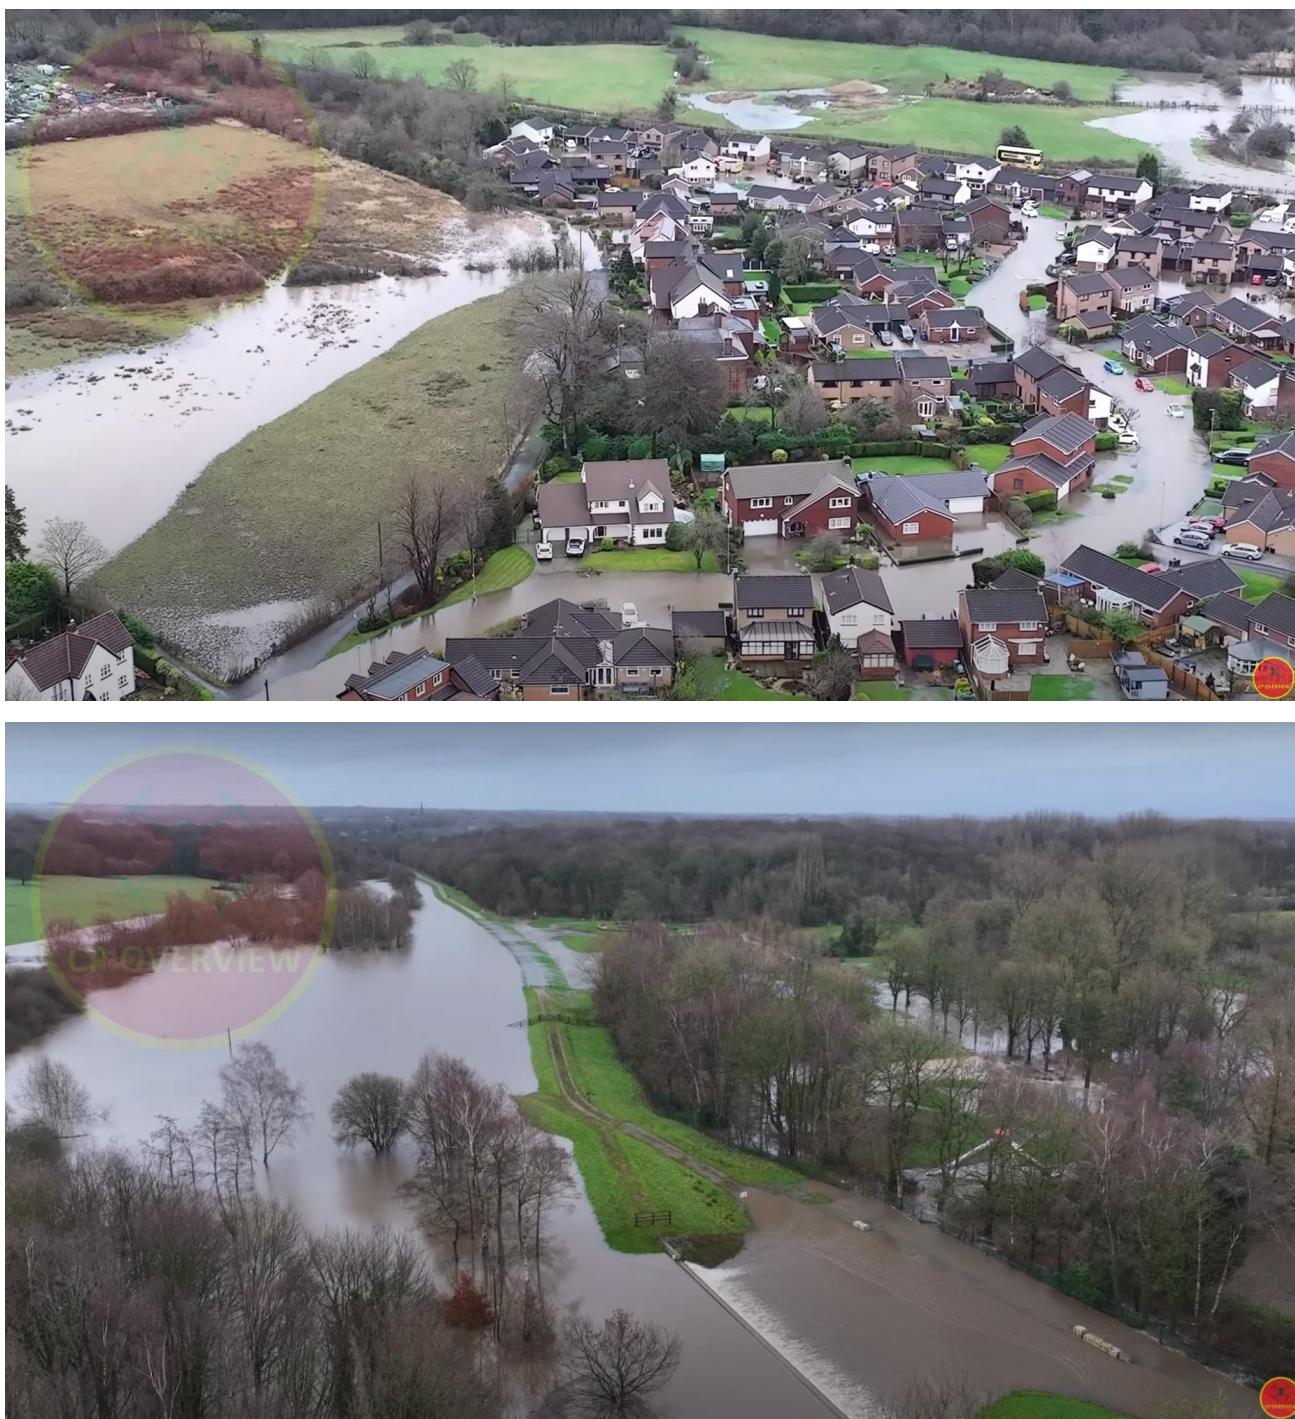
Figure 6-2: Drone footage showing flood extents across the Lilford Park area (CP Overview, 2025)¹.

Figure 6-1 shows the pathways of the floodwater during the event on 1 January 2025. The pathways are also seen in the drone footage in Figure 6-2.

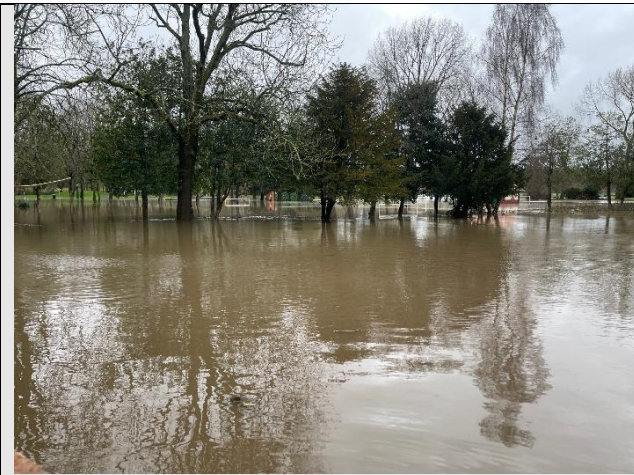
The flood storage reservoir exceeded its capacity and water overflowed both spillways. Floodwater from the secondary (eastern) spillway flowed south into the park, resulting in a pathway across the horse field and down to the residential area by Wood End and Eden Bank. The primary (western) concrete spillway also overflowed and added to the volume of water in the park (Photo 3).

Photo 3: Floodwater in Lilford Park
(Source: Lilford Park residents).

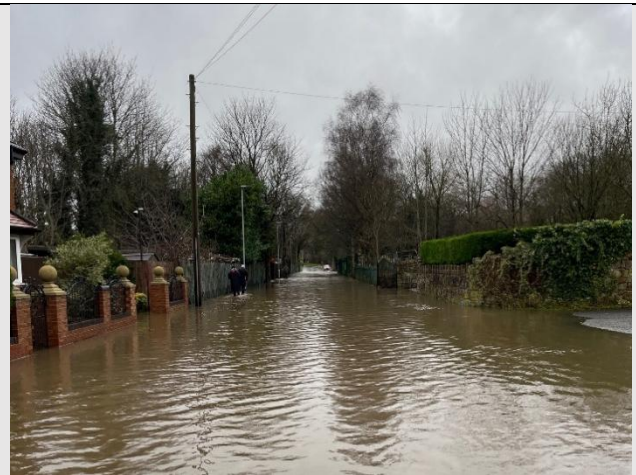
Floodwater from the primary (western) concrete spillway also resulted in a flow path across the majority of Elmridge (Photo 4). The flood water travelled partially up Greenways but did not flood any properties internally. The eastern flow path that had travelled through the park internally flooded at least two properties on Wood End and at least one on Eden Bank. The flow path travelling onto Elmridge then joined with the other flow path (Photo 5). At least 12 properties on Elmridge internally flooded. The combined flow from the two flow paths then continued further south, onto Hathaway Court where at least 10 properties flooded internally. The water then flowed between the houses in the south of Hathaway Court and across the busway to an area of green space adjacent to the watercourse.

Photo 4: Floodwater on Elmridge, looking
northwest with the park to the right side
(Source: Lilford Park residents).

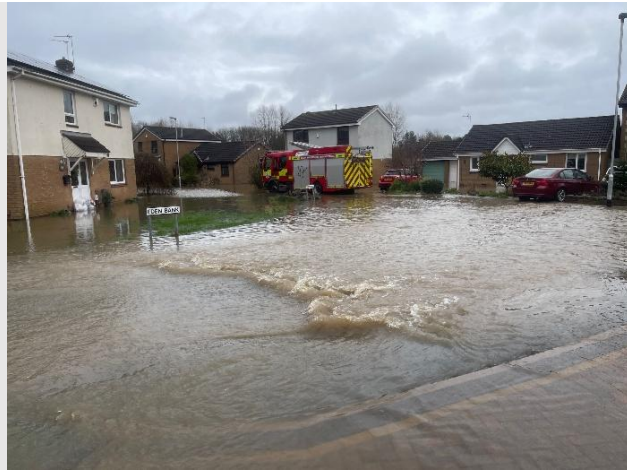
Photo 5: Floodwater on Elmridge and entrance to Eden Bank (Source: Lilford Park residents).

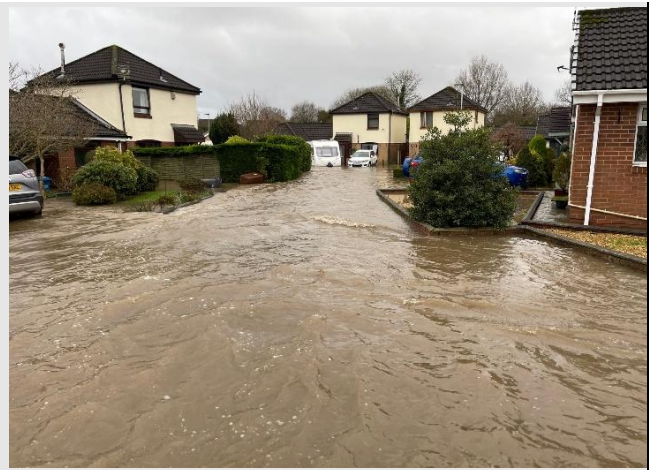
Photo 6: Floodwater on Hathaway Court (Source: Lilford Park residents).

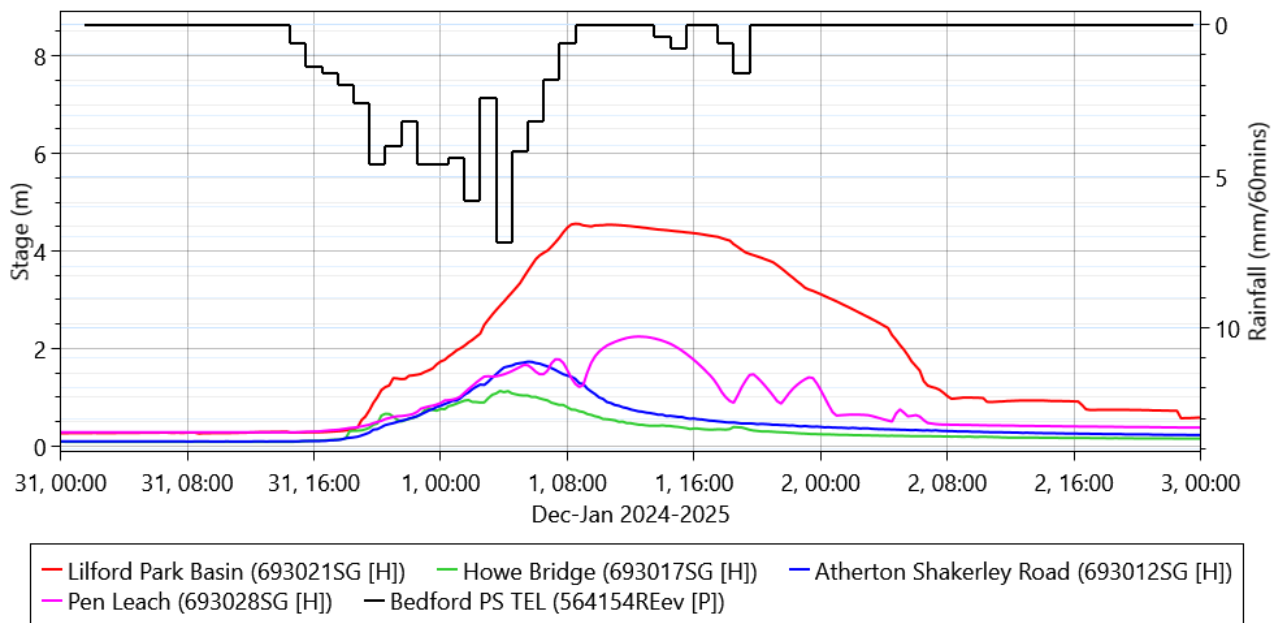
Figure 8-5: Fluvial response to the rainfall event.

The peak rainfall occurred overnight from 31 December 2024 to the early hours of 1 January 2025, peaking in intensity between 00:00 to 04:00. The local gauging stations show a typical north-to-south flood response as the flood wave progressed through the catchment, following the flow direction of the local streams. River levels at the Lilford Park Basin gauge started to rise in the evening of 31 December with the peak level occurring at 08:30 on 1 January. The peak river level coincided with the reported flooding at many of the affected properties. The peak at the Atherton Shakerley Road and Howe Bridge gauges occurred slightly earlier (between 04:00 to 05:30) as these gauges are situated upstream. The location of Bedford pumping station downstream of the Pen Leach gauge will likely affect the level recorded, as shown in the unusual profile for Pen Leach on the hydrograph. This is likely a result of pumps switching on and off as designed throughout the flood event.
