Platt Bridge Section 19 Flood Investigation Report

Final Report

May 2025

Prepared for:
Wigan Council

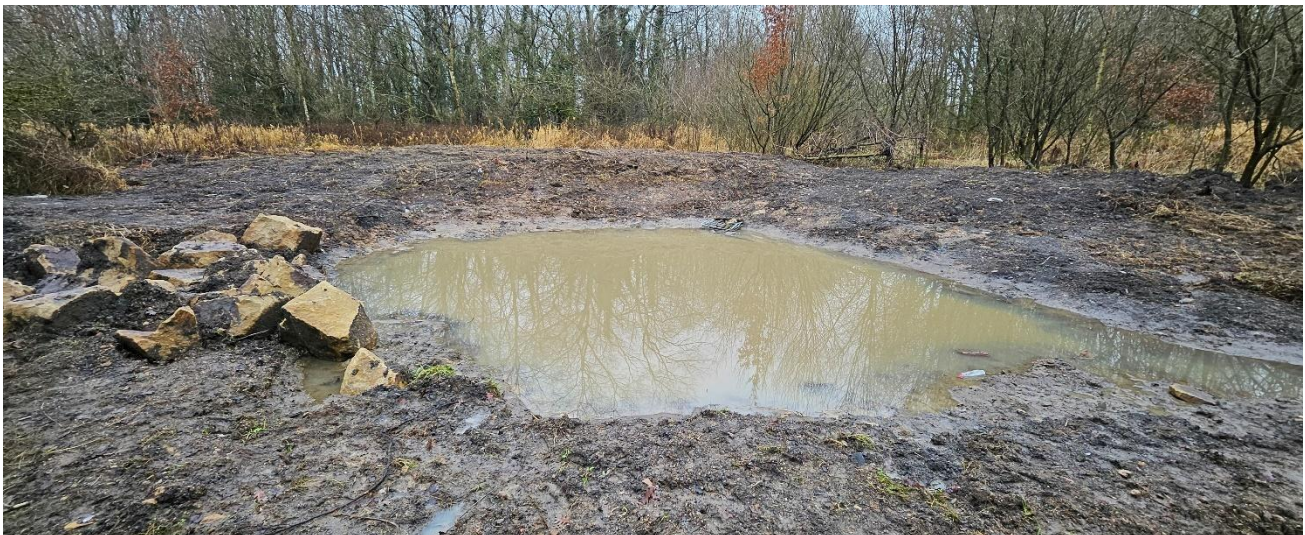
Figure 3-4: Scrape installed upstream of Bickershaw Lane along Brookside Brook Drain.

Three small scrapes have been installed upstream of Bickershaw Lane along the path of Brookside Brook Drain to capture overland flow (Figure 3-4). However, it has been noted that the scrapes are relatively ineffective, due to the soft ground. During a Bickershaw Lane Flood Action Group meeting on 1 April 2025, residents explained that the scrapes have also not held flows as they are inundated by groundwater.

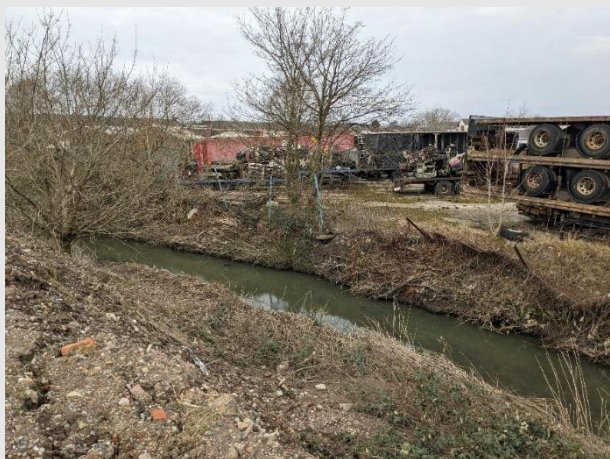
Photo 1: Low point on the right bank of Hey Brook (Source: JBA Consulting).

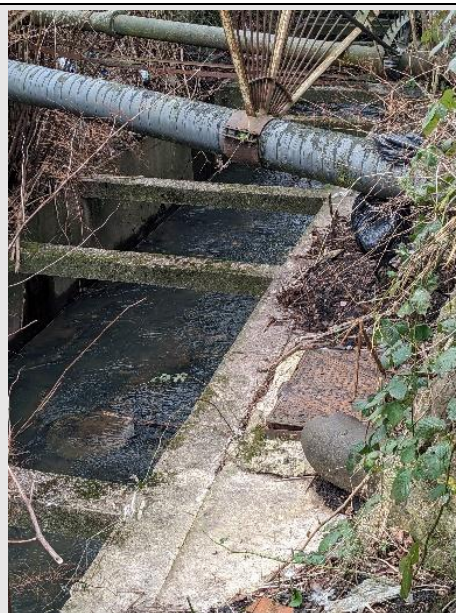
Photo 2: Highway drain outfall into Hey Brook (Source: JBA Consulting).

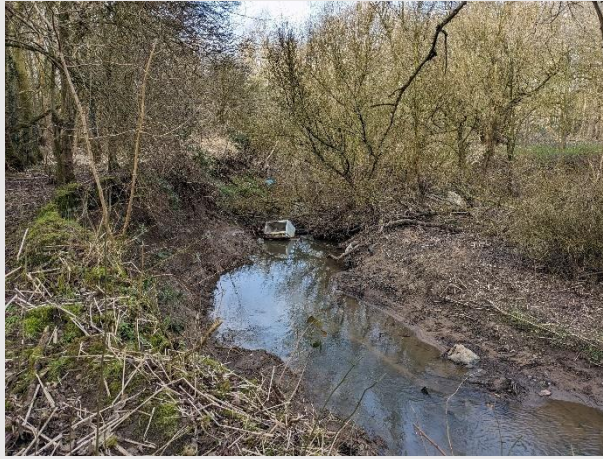
During the site visit undertaken by JBA Consulting, it was noted that there was evidence of obstructions in the channel in places as a result of fly-tipping (Photo 3), however given the volume of rainfall, this reduction in channel volume is unlikely to have had a considerable impact on the capacity of the channel and volume of floodwater overtopping the channel.

Photo 3: Channel obstruction due to fly tipping within Hey Brook (Source: JBA Consulting)

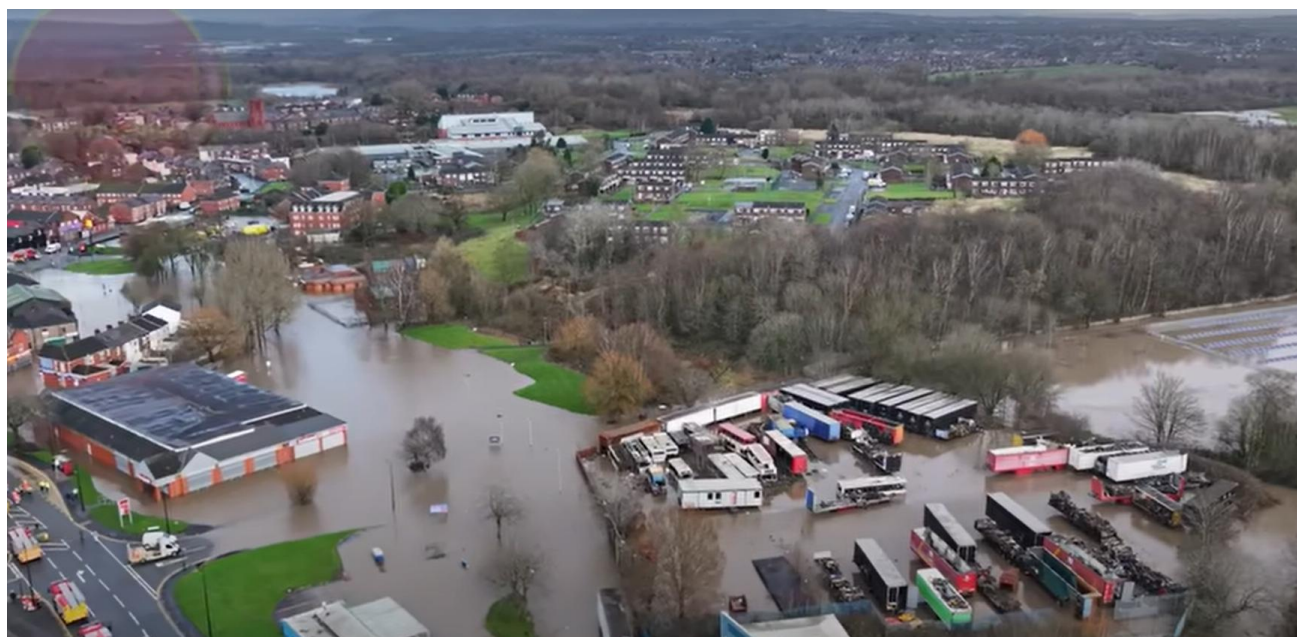
Figure 6-2: Drone footage showing flood extents across the Templeton Road area (CP Overview, 2025)¹.

Drone footage from the event shows the flood extent and area impacted across the Templeton Road area (Figure 6-2).

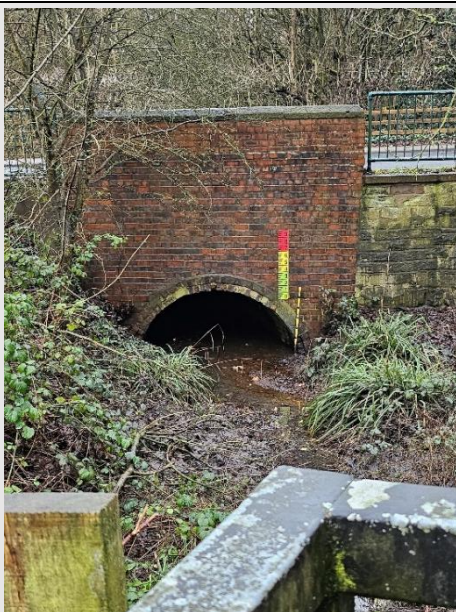
Photo 4: Culvert where Brookside Brook drain passes beneath Bickershaw Lane (Source: JBA Consulting).

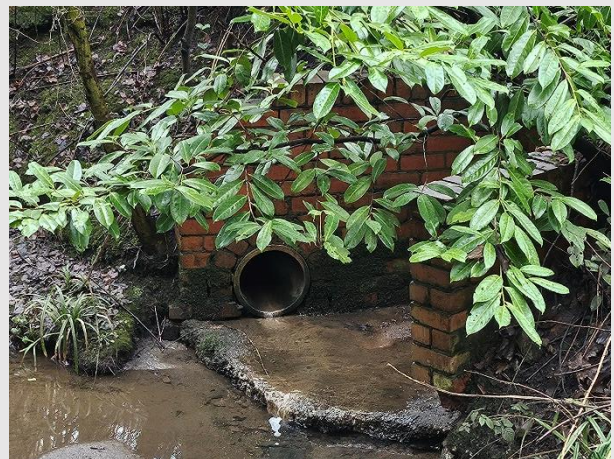
The high level in Brookside Brook Drain also meant that the outfalls of the highway drainage for Keats Way East and the United Utilities surface water sewer which takes surface water from the south were submerged (Photo 5 and Photo 6).

Photo 5: United Utilities surface water sewer which outfalls into Brookside Brook Drain. The Highway drain outfall is situated to the right (Source: JBA Consulting).

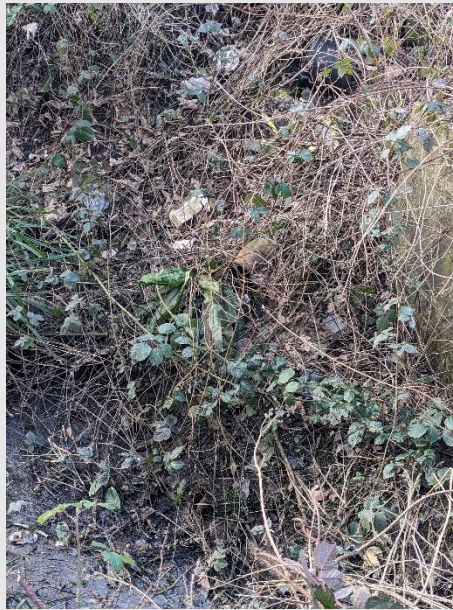
Photo 6: Highway outfall pipe into Brookside Brook Drain (Source: JBA Consulting).
