# **Flood Investigation Report**

## **Higher Folds Estate, Leigh**

**July 2025**

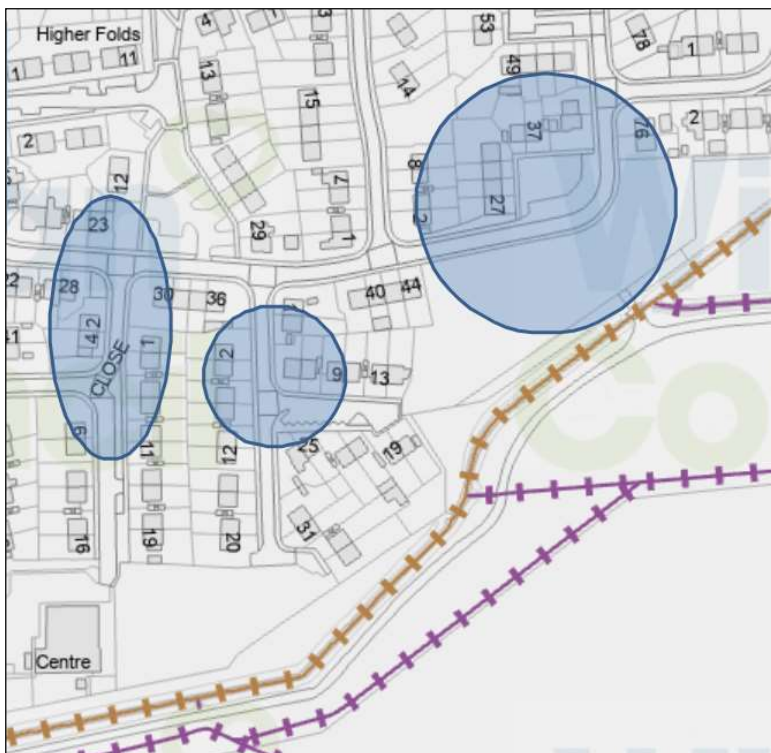
Figure 10. Areas of Flooding

Due to a combination of causes, the outfalls from the public surface water system became blinded and unable to discharge freely and effectively into the river. This caused the network to back up and then flood water surcharged out of the United Utilities manhole at the top of Stirling Close and adjacent to 76 Royal Drive. From here the water began to pond around the Royal Drive/Stirling Close junction, and also further round on the bend near 27 Royal Drive. As the rain continued the water began to breach the properties at both locations.

Following discussions with the residents, it has been assumed that the properties affected on Crown Grove were flooded from the foul network running behind the properties, this was a result of the outfall being submerged and unable to discharge, causing the system to back up and flood out.

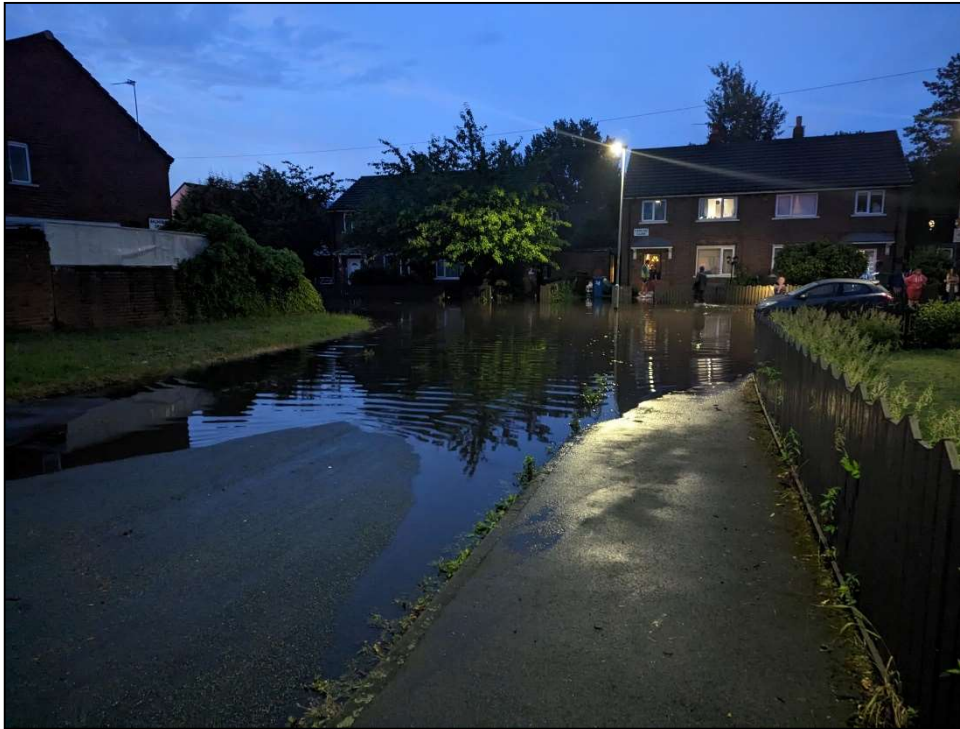
*Picture 1. Taken from junction of Balmoral Drive looking towards Stirling Close.*

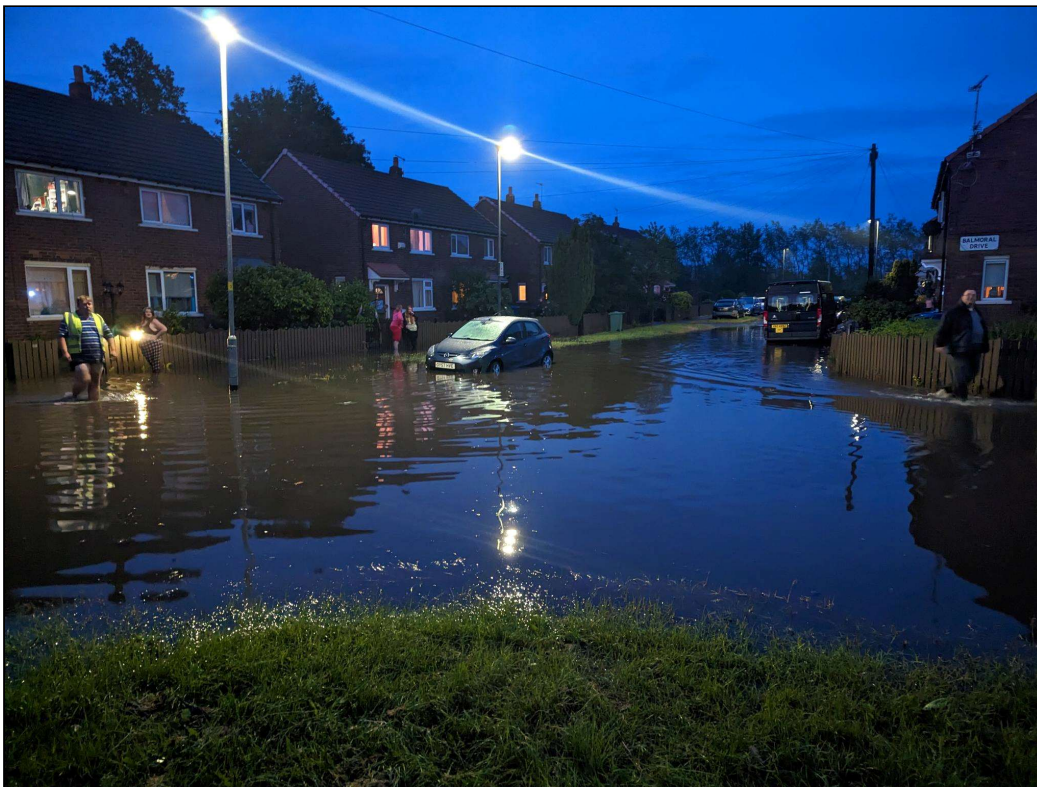
*Picture 2 - Junction of Balmoral Drive and Stirling Close*

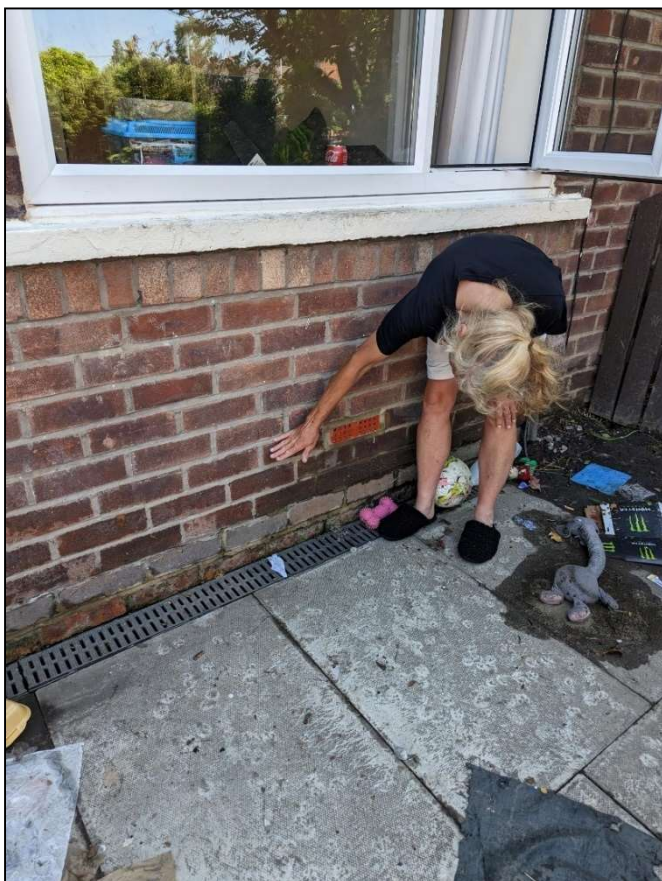
*Picture 3 – Indication of water level*

Picture 3 above shows a resident indicating the approximate level the water reached outside the properties on Stirling Close.

Residents reported external flood depths of approximately 500mm (see picture 3). The Environment Agency estimation of potential depth shows that Stirling Close has a high risk of flooding to a depth of 300mm, rising to a high 600mm level in 2040-2060.

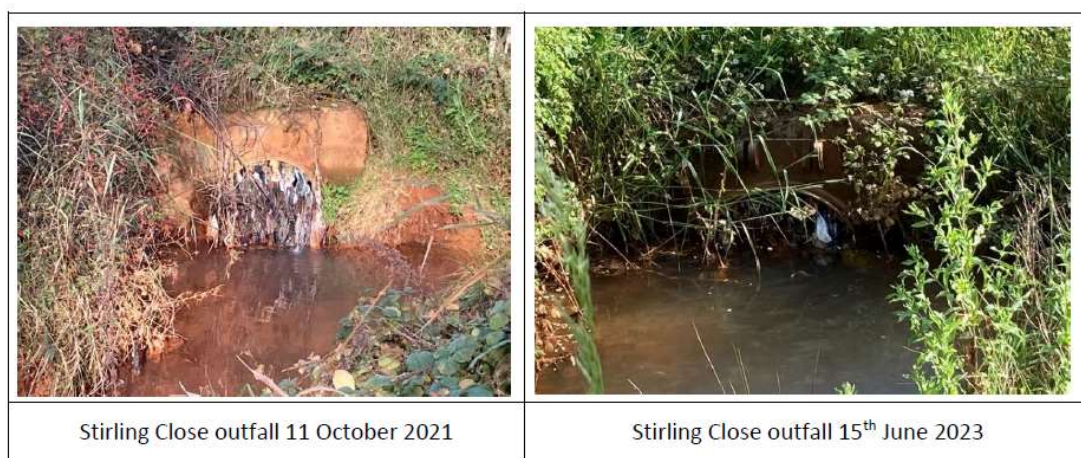
*Picture 4. Stirling Close Outfall*

The main contributing factor to the flooding at Stirling Close was attributed to the surface water outfall being blocked by litter and debris trapped by the grill on the end of the outfall, along with being hydraulically locked due to the high water level in the Brook. This is similar to the situation in 2021.

Following the incident, United Utilities have surveyed the public surface water and no operational issues were found on the network, the outfall

however was found to be blocked. Due to the consistent high levels in the brook, it is impossible to determine if the outfall was blocked before, during or after the storm.

UU have increased the inspection visits for the outfalls from an annual inspection to a quarterly visit following the incident in 2021. These inspections did highlight issues with high silt levels in the watercourse.

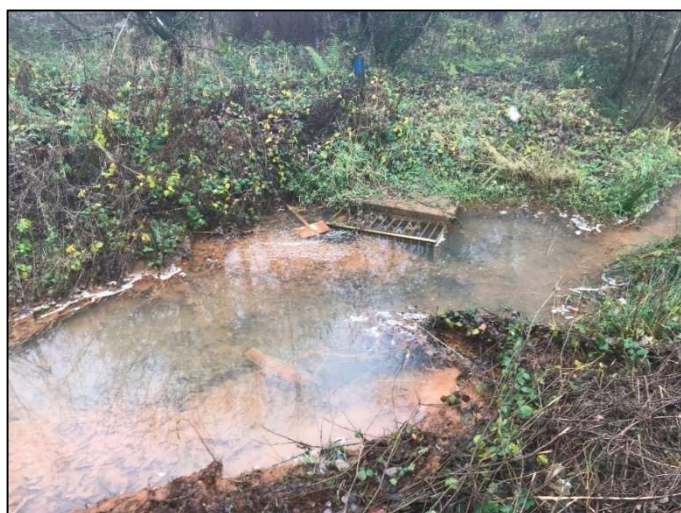
*Picture 5. Royal Drive Outfall*

At Royal Drive the outfall was blocked by river silt due to the river level continually increasing. This causes the public sewer outfall to become submerged and therefore unable to discharge freely.

United Utilities engaged with the Environment Agency and the Forestry Commission in an effort to get the river desilted, to allow free discharge from the public outfalls.

Following the flooding the Environment Agency commissioned their internal geomorphologists to study the silt levels in the brook and recommend what needs to be done. They recommended de-silting the brook. The Environment Agency discussed this recommendation with Wigan Council, United Utilities and Forestry Commission to agree who will carry out these works. As a result the Environment Agency carried out a de-weeding and desilting operation in November 2023, followed by the start of continual monitoring of in-channel silt levels which began in January 2024.

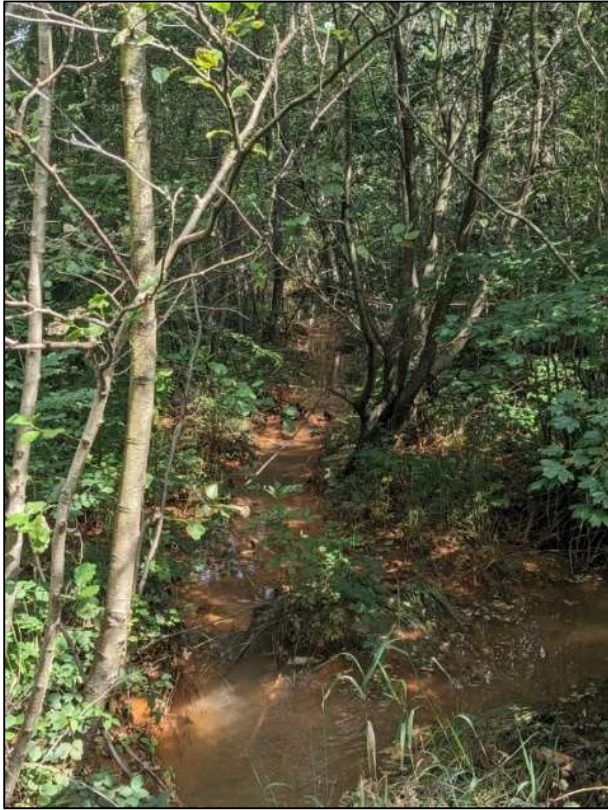
The upstream section of the Brook leading to the rear of Sandringham Drive is very overgrown with vegetation encroaching on the watercourse in some sections. Although this vegetation can help in holding back water it can also increase risk due to passing forward water, debris and litter etc, that increases blockage risk further downstream.

*Picture 6. Upstream of Brook to rear of Sandringham Drive*

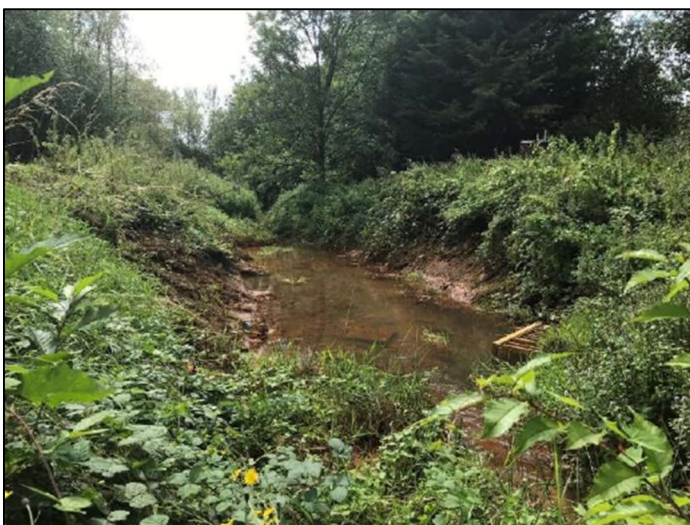
Downstream of the Royal Drive outfall the watercourse appears to have been widened and is heavily silted up. This siltation is causing a blockage in front of the outfalls.

*Picture 7 Downstream of Royal Drive outfall*
