## AREA 5.E BICKERSHAW

## AREA 5.G

## PICKLEY GREEN

## AREA 5.H      GIN PIT

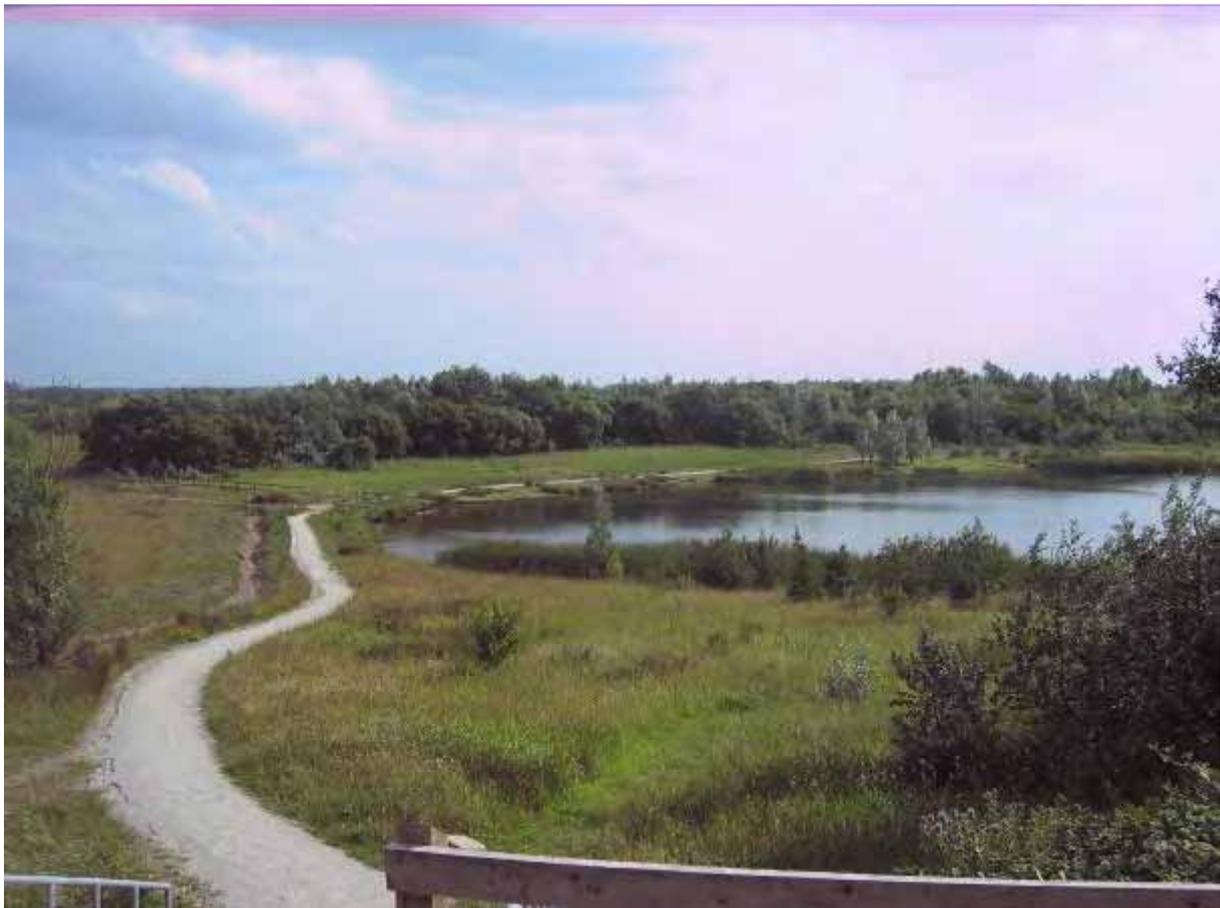
Photo. 103 New Park, Tamer Lane End.

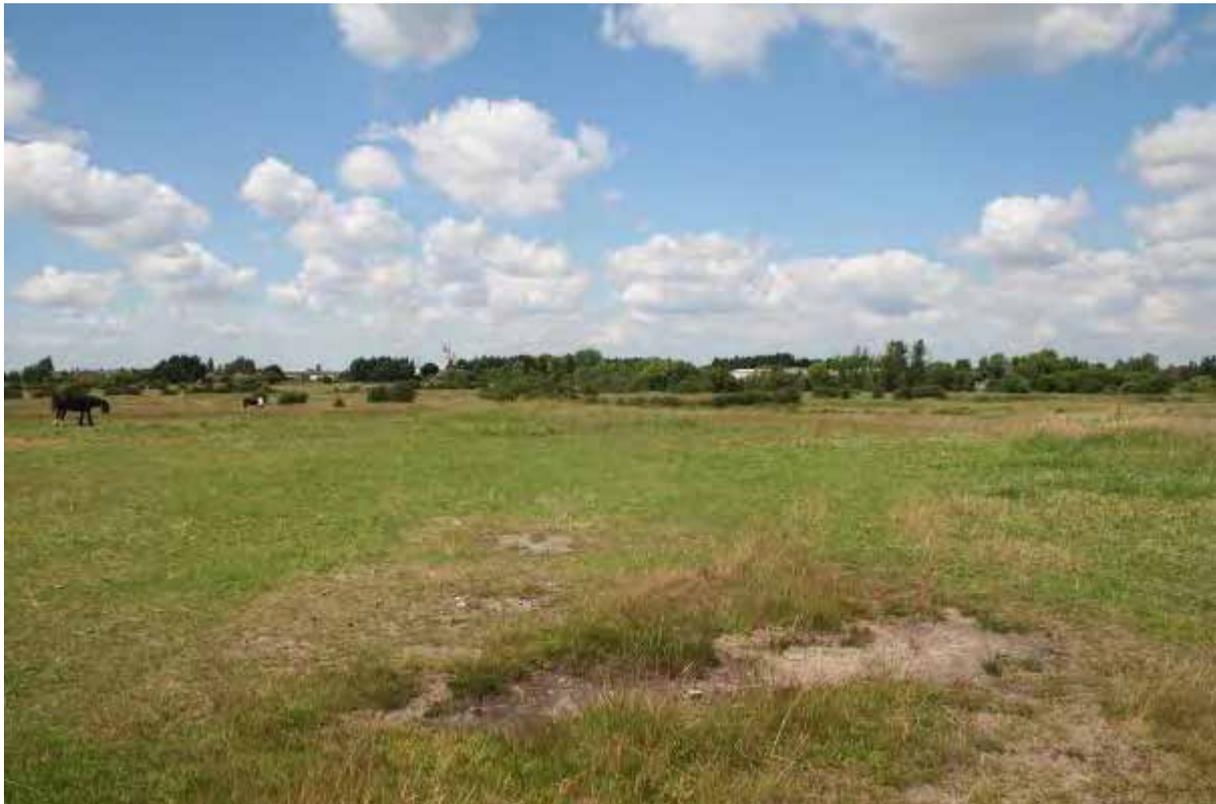
Photo. 145 Abbey Lane Tip, Dangerous Corner.

The spoil areas are sparsely vegetated with woodland planting to the south. Small areas of remnant hedgerows are apparent to lower, original ground levels to the west. The area appears to be unmanaged, disrespected and poorly reclaimed. It is currently used unofficially for tethered horse grazing and the site fringes have been subject to fly-tipping

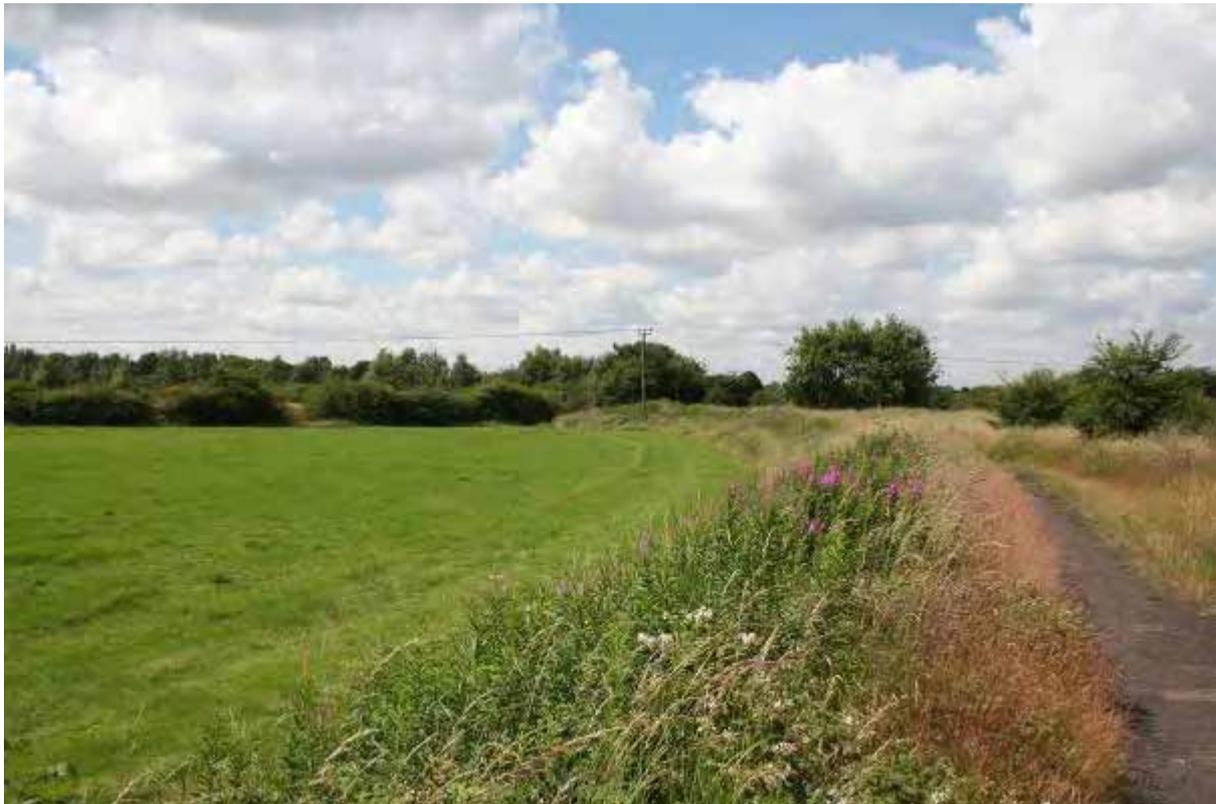
Photo. 148 Pickley Green; disused mineral railway to the right.

The old disused railway lines form an historic structure to the area, but these are often badly drained or show signs of erosion to their embankments. The informal footpath routes which follow the line of the old railway tracks are well-used recreationally, although often mis-used used for fly-tipping and motorbike riding.

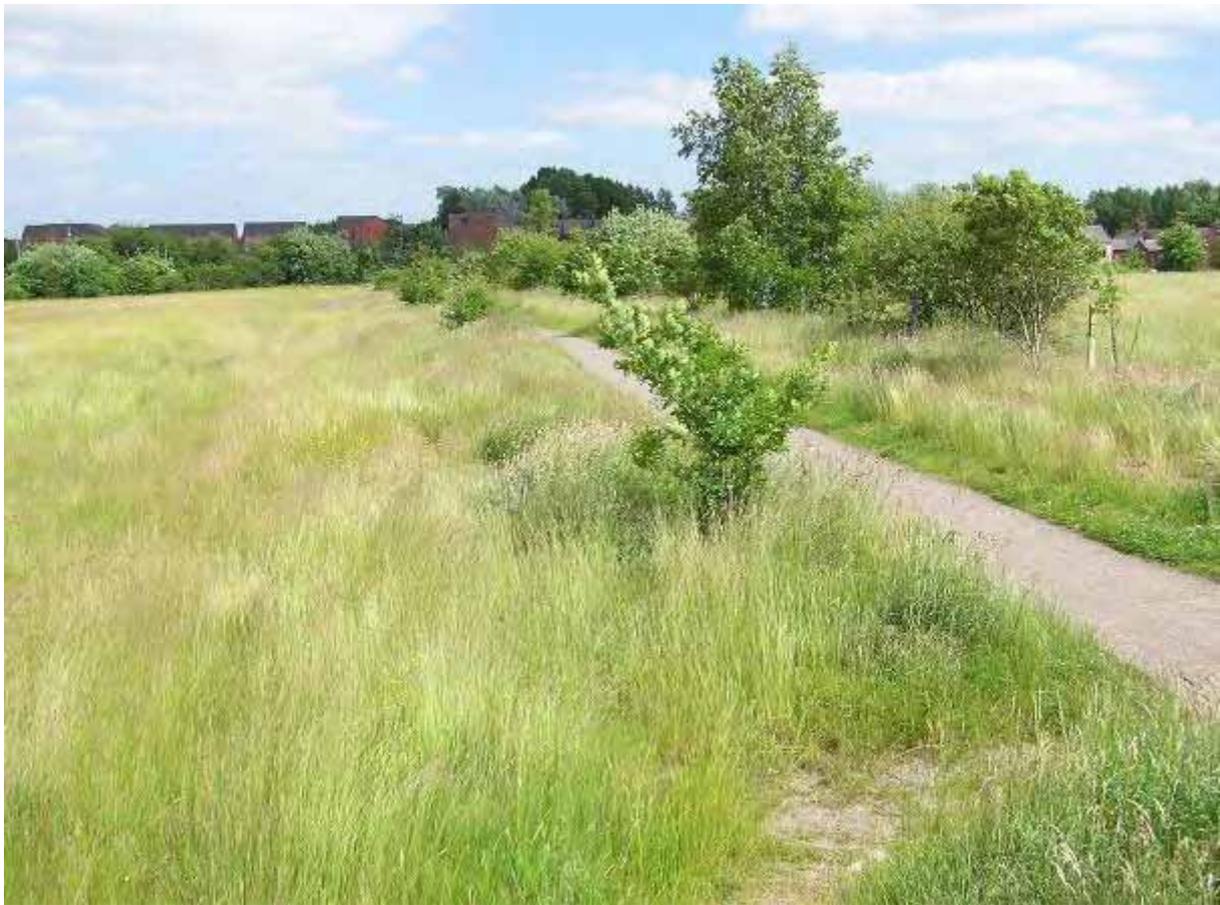
The area largely comprises of a former colliery spoil heap which has been re-graded to form a simple but large-scale, generally dome shaped mound with gently sloping sides. Woodland plantations are present around the boundary, particularly to the residential areas of Higher Folds, together with interlinked strip planting which divides the area into a series of grassed open spaces. The open space areas are of a very large-scale nature, contrasting with the surrounding heavily built-up urban areas. The woodland plantations are now reasonably mature, creating a landscape framework which is also valuable for wildlife.

Photo. 86 Gin Pit.

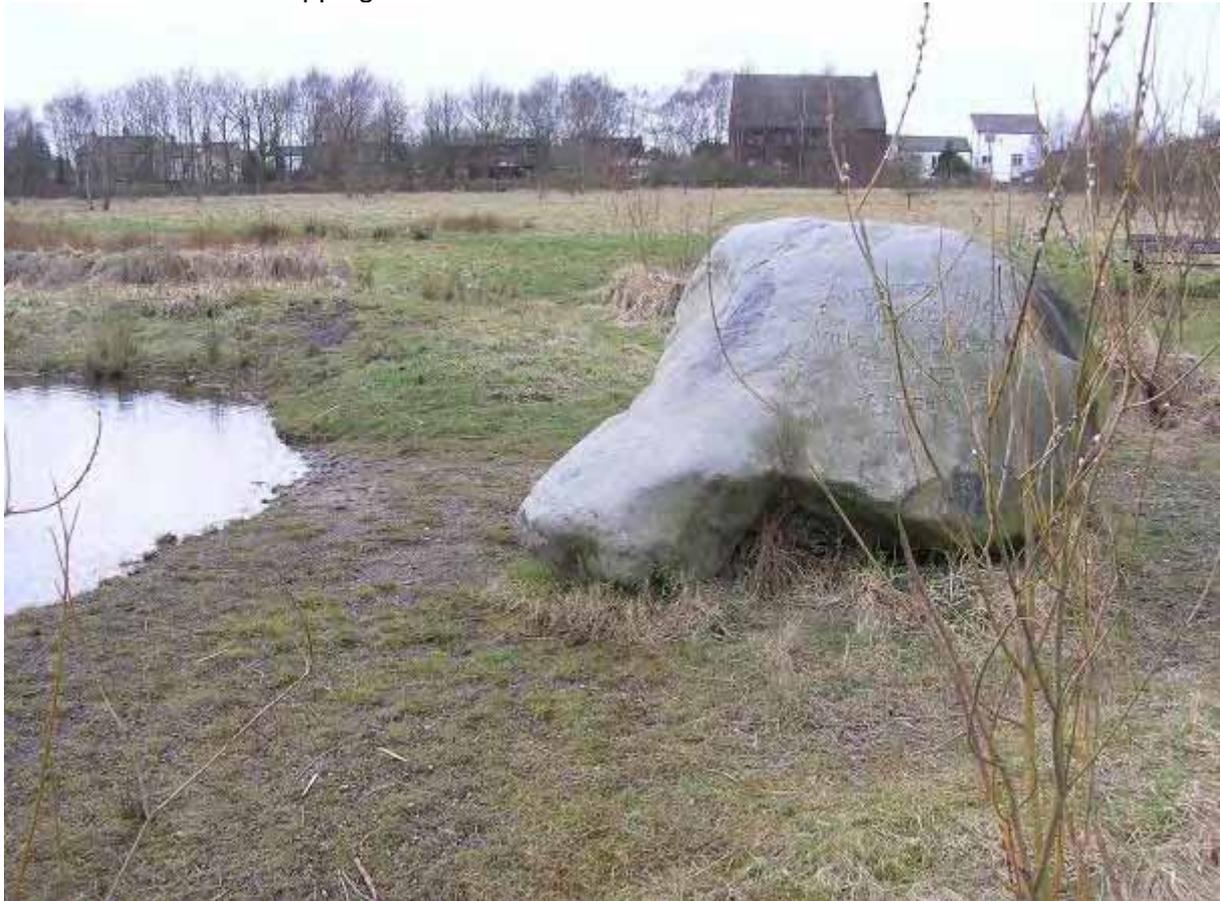
Photo. 3 Millenium Green, Astley Green.

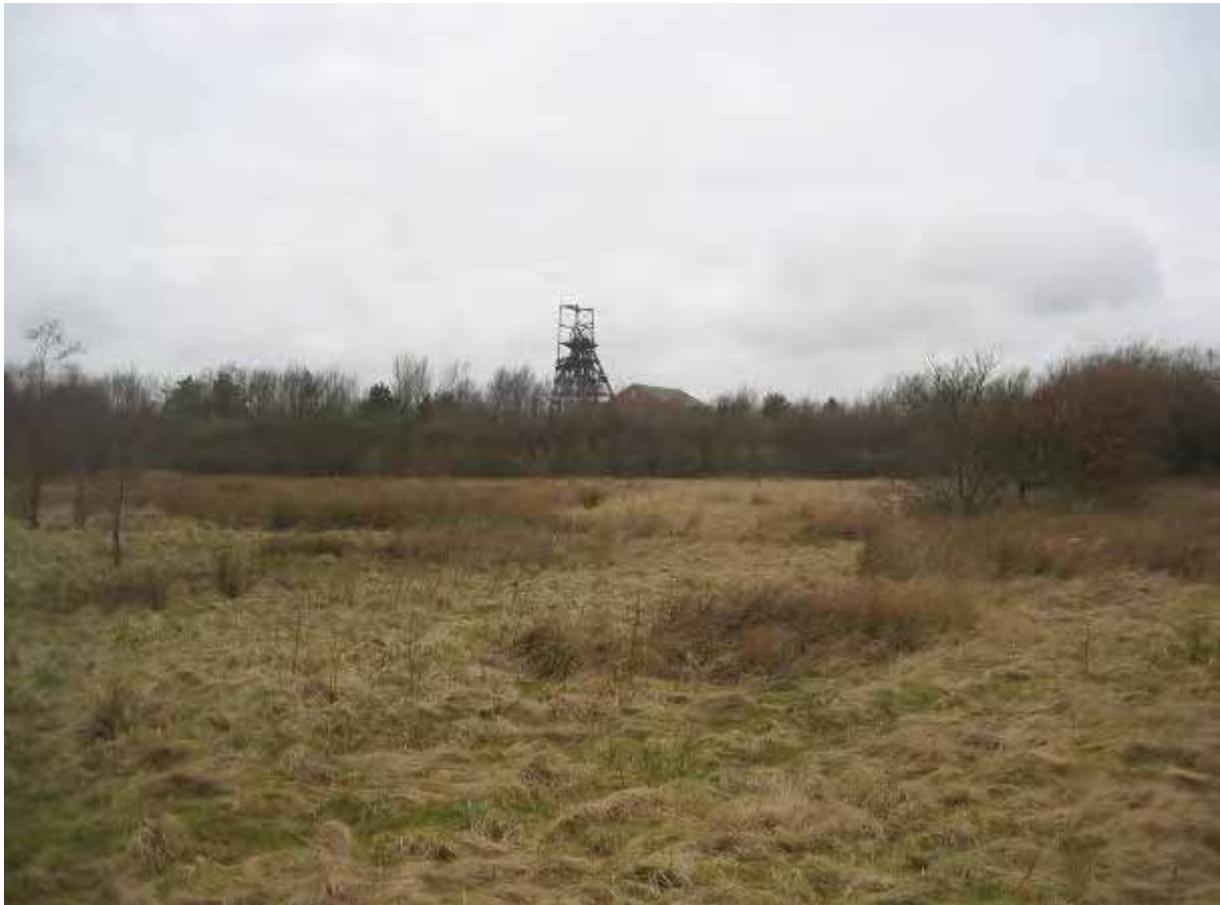
Astley Green Colliery, commenced in 1908 by the Clifton and Kersley Coal Company was built to access coal under the mossland. The moss and clay 'overburden' was 30m thick and it was the technical inability to mine through this which had until this date protected the coal reserves. The shaft was sunk using a 'drop shaft' method, which used an iron cylinder with teeth at the base to be forced into the ground with hydraulic jacks, counterweighted by a large masonry thrust pillar. The pit closed in 1970 and demolition of the colliery commenced that year. Only the winding gear and the building housing the Astley Green Colliery Museum remain.

Photo. 1 Astley Green Pit winding gear.
