# **Flood Investigation Report Havenwood Road, Whitley**

**November 2023**

**Flood Investigation Report**

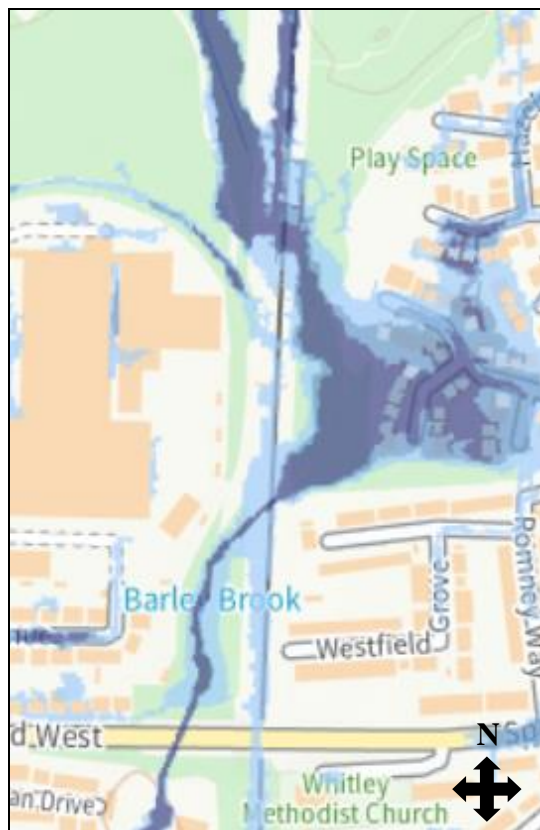
*Figure 2. Environment Agency Surface Water Flooding Map*

The estate is mapped as in an area of high risk from river and surface water flooding on the Environment Agency mapping service, as shown below.

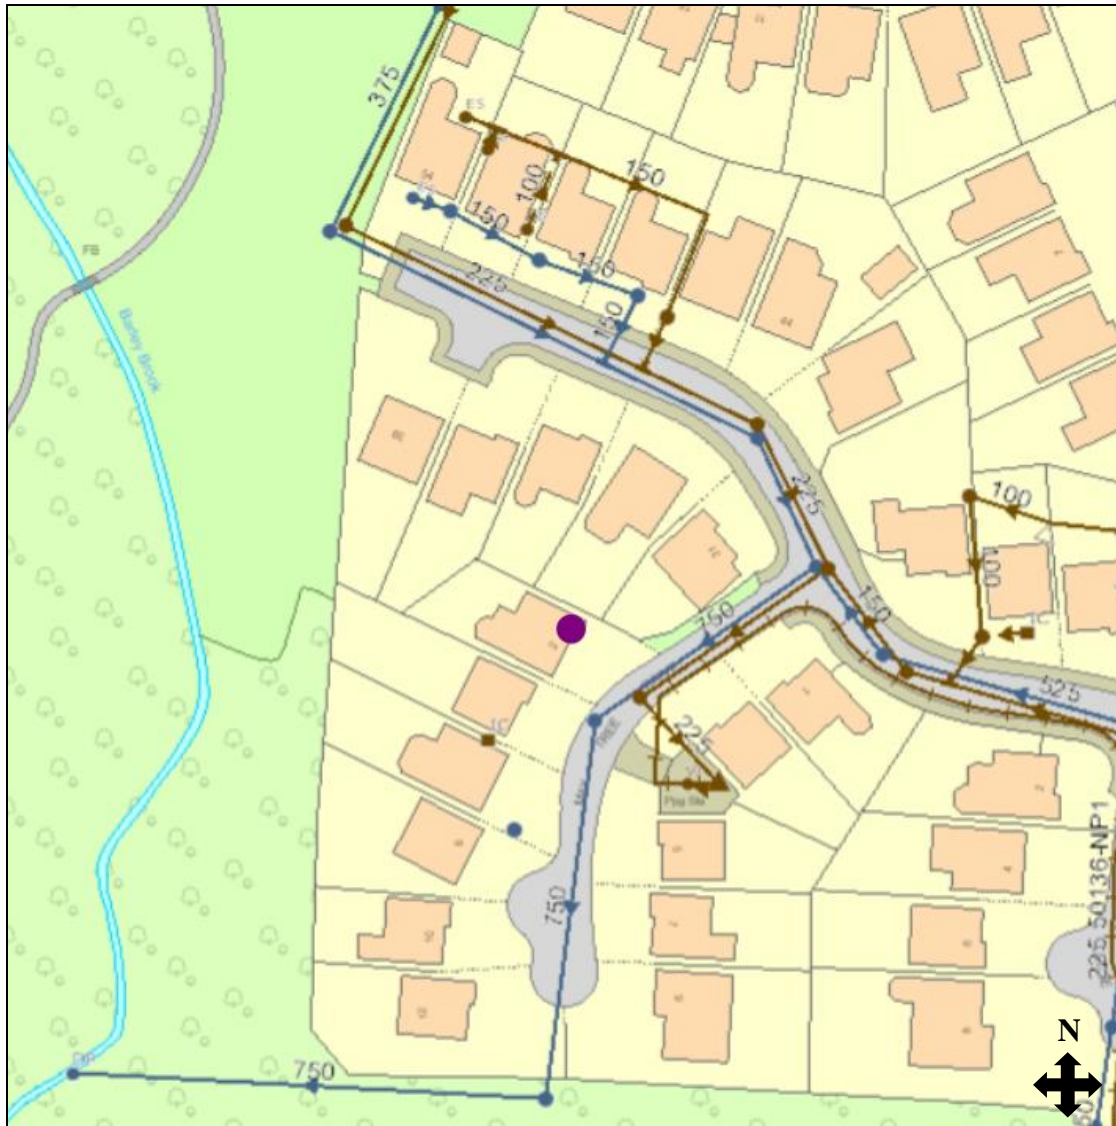
Figure 3. Sewer Plan

Havenwood Road is predominately served by a separate system with both a foul and a surface water sewer system as shown in Figure 2 below. This system is owned and maintained by United Utilities.

The blue line indicates the surface water system with the brown indicating the foul system.
