Lincoln Drive Section 19 Flood Investigation Report

Final Report

June 2025

Prepared for:
Wigan Council

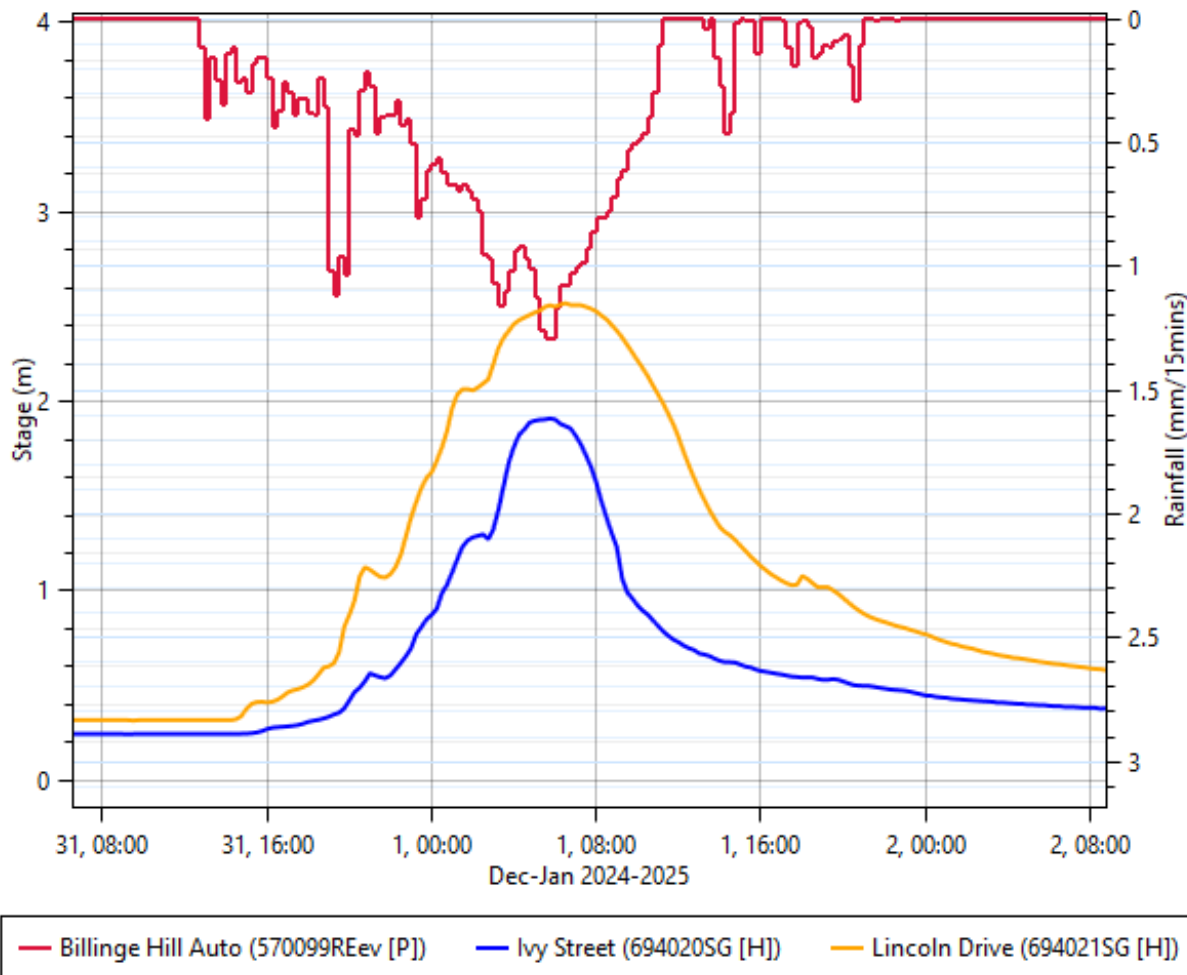
Figure 5-2: Fluvial response to the 1 January 2025 flood event at nearby river level gauges.

Figure 5-2 shows the fluvial response of the Millingford Brook to the 1 January flood event, versus the closest rain gauge to the catchment (Billinge Hill). There was a short lag time between the rainfall and subsequent hydrograph peak.

gauge is located lower in the catchment and captures a greater volume of runoff from the surrounding urbanised catchment, relative to Ivy Street.

- The rainstorm was less intense after 06:00, with river levels falling relatively quickly, returning to high baseflow conditions around 18:00 on 1 January.

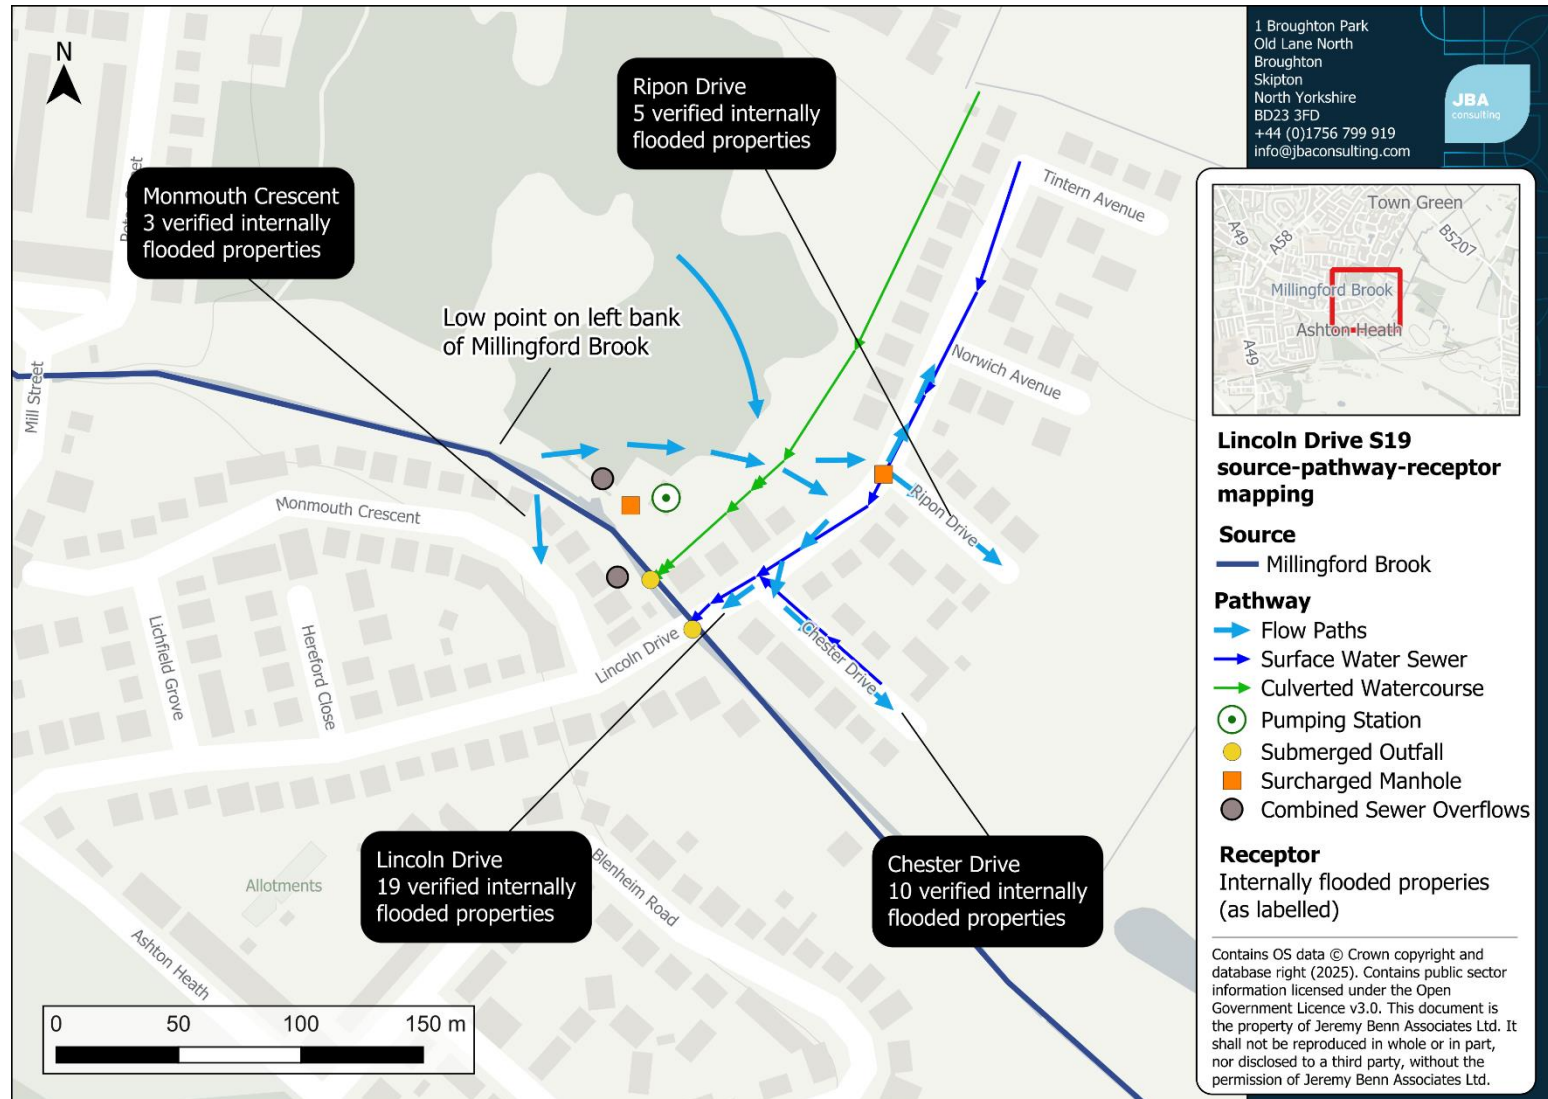
Figure 6-1: Map of the sources, pathways, and receptors in the Lincoln Drive Area.

Figure 6-1 shows the pathways of the floodwater during the event on 1 January 2025. The Millingford Brook overtopped both banks. Fluvial flooding resulted in one pathway where water flowed south onto Monmouth Crescent. A pathway also flowed eastwards from the Millingford Brook, towards the area around the pumping station at the back of the houses on Lincoln Drive. The questionnaire responses from residents also noted that the Millingford Brook overtopped further downstream, flowing into rear gardens and outbuildings on Blenheim Road.

There is a surface water sewer outfall under Lincoln Road bridge that was unable to discharge during the flood event. This was due to the water level of the Millingford Brook exceeding the height of the outfall, meaning it was submerged. There is no flap valve at this outfall to prevent water/debris flowing back into the pipe. Therefore, it is likely that water flowed back up the system and came out at low spots of land. There is another unprotected outfall directly upstream of the bridge on Lincoln Drive, but this one is from a non-main watercourse. It is probable that a similar issue occurred with this outfall being unable to discharge. The inability of water to discharge due to the submersion of these outfalls resulted in surface water flooding from the gullies and manholes. Two reported surcharged manholes are mapped in Figure 6-1.

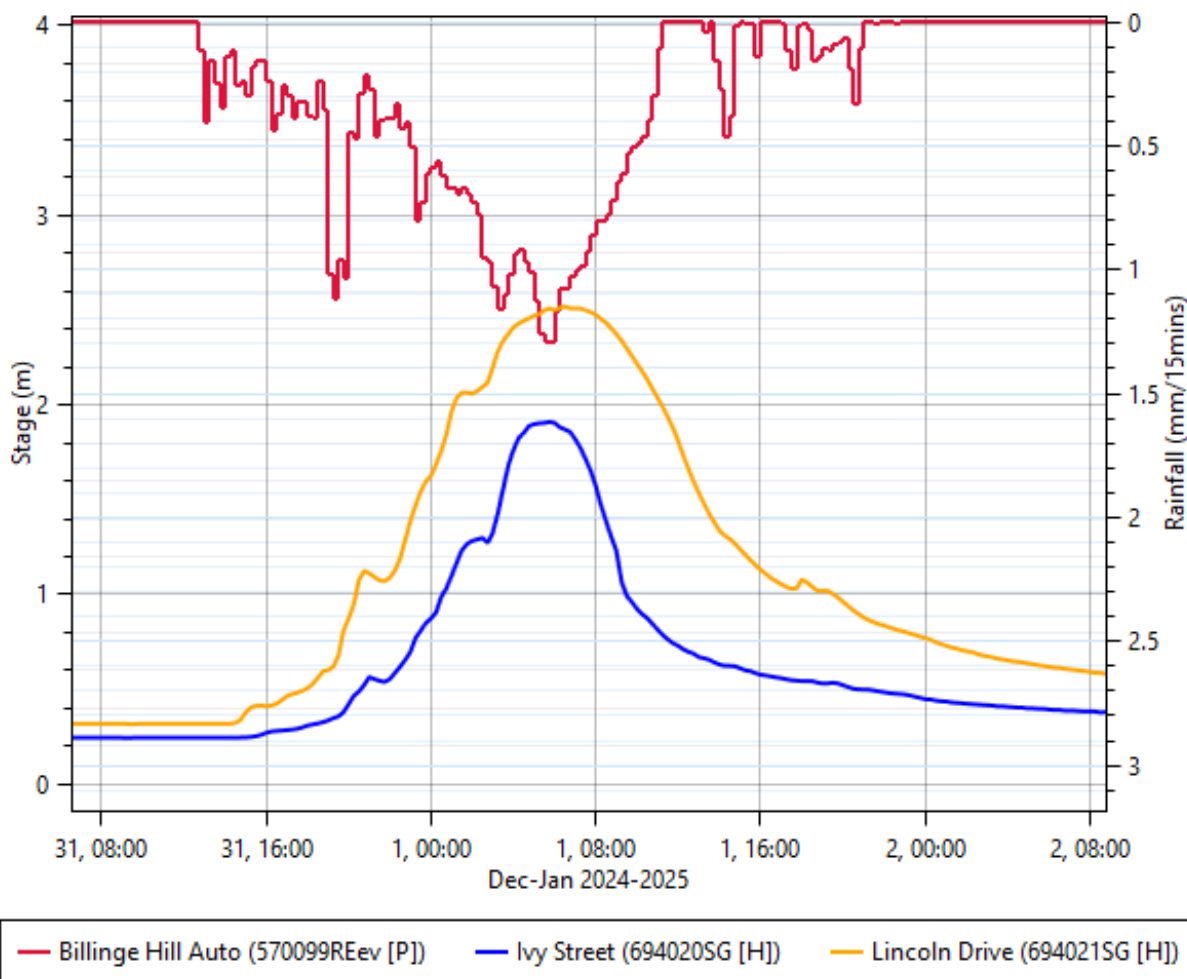
Figure A-4: Fluvial response to the 1 January 2025 flood event at nearby river level gauges.

Figure A-4 shows the fluvial response of Millingford Brook to the 1 January flood event, versus the closest rain gauge to the catchment (Billinge Hill). There was a short lag time between the rainfall and subsequent hydrograph peak.

- The rainstorm began around 12:00 on 31 December, with river levels showing a response from 18:00 onwards.
- River levels rose continuously in response to the persistent rainfall, peaking around 06:00 on 1 January.
- The hydrograph peak persisted for a longer time at Lincoln Drive relative to Ivy Street, likely due to the relative positions of these gauges. The Lincoln Drive gauge is located lower in the catchment and captures a greater volume of runoff from the surrounding urbanised catchment, relative to Ivy Street.
- The rainstorm was less intense after 06:00, with river levels falling relatively quickly, returning to high baseflow conditions around 18:00 on 1 January.

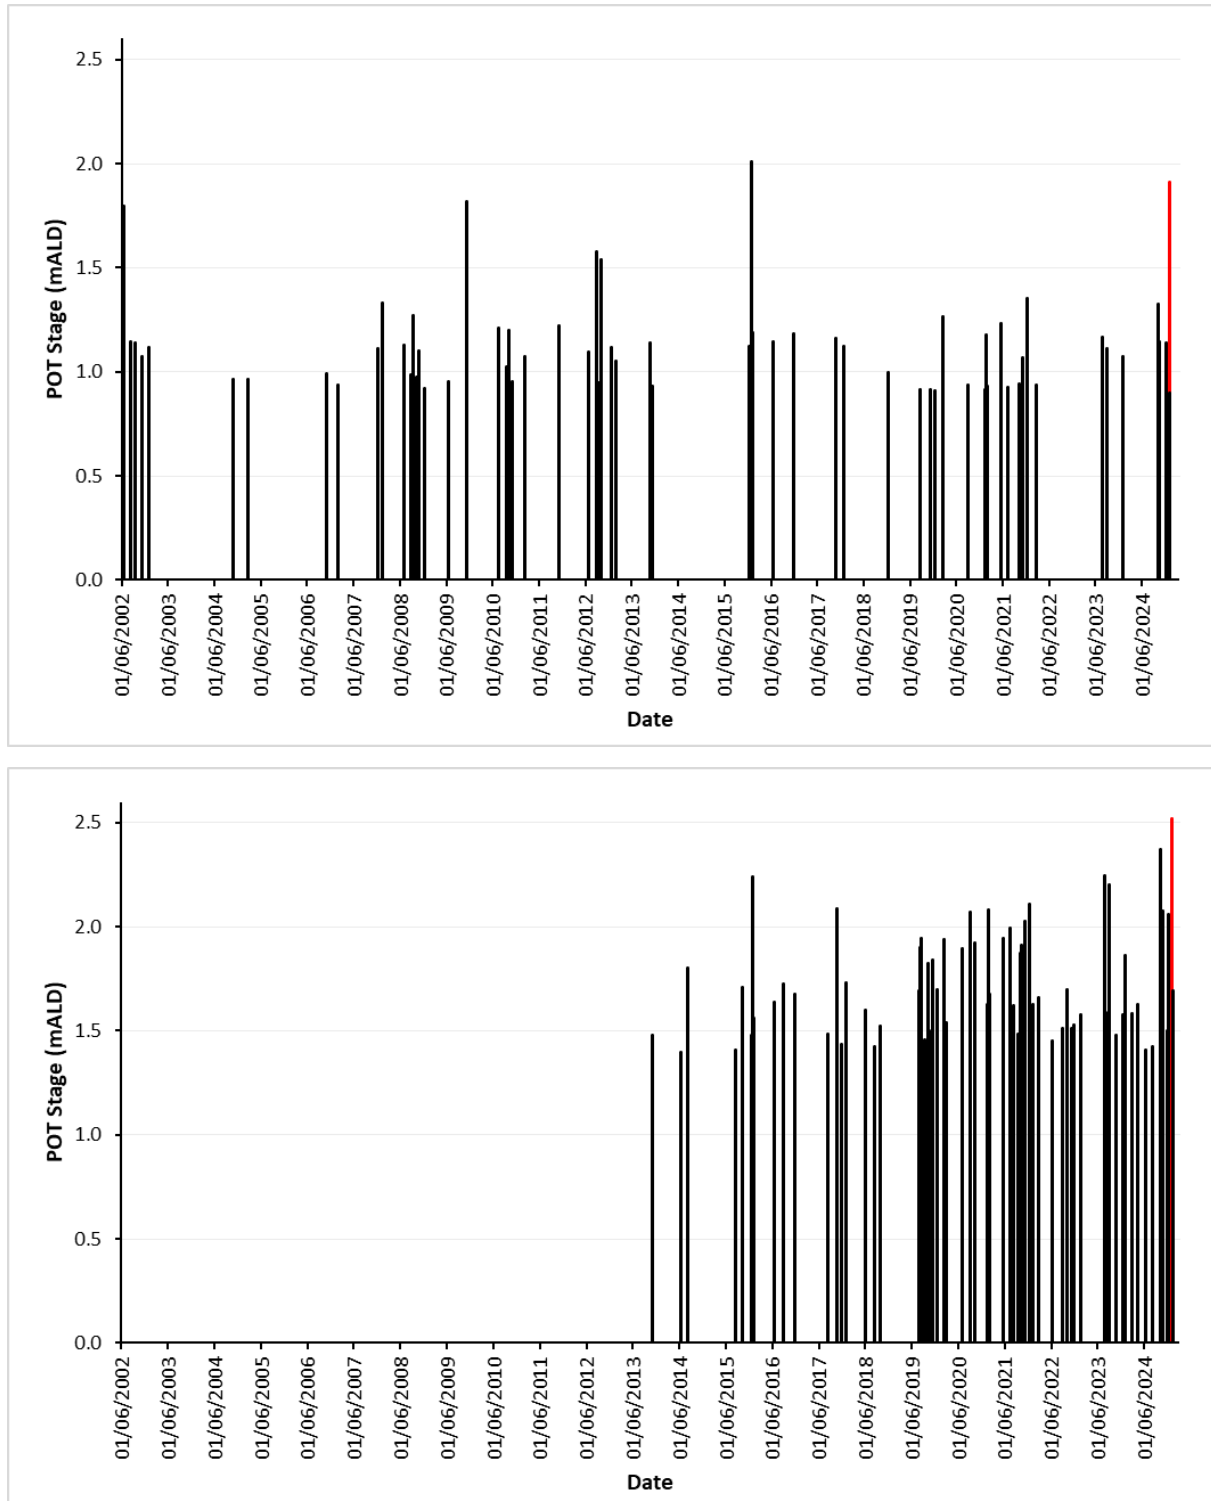
Figure A-5: POT level series for Ivy Street (upper) and Lincoln Drive (lower).

The Ivy Street gauge alone informs the following interpretations, as a result of the uncertainties listed above for the Lincoln Drive level gauge, which would unrealistically skew the event rarity assessment.

The 1 January 2025 event is the second-largest peak in the available 24-year record length at Ivy Street with a locally recorded peak level of 1.911m above local gauge datum (mALD). This was exceeded by 0.10m by the 26 December 2015 flood event, which was a widespread flood event seen at most gauges in northern England. The third-largest POT event was 0.09m lower, recorded on 4 November 2009.
